YUNGDRUNGLING MONASTERY Conservation Project Report

by André Alexander and Christine Jürgens,
with Nyima Tsering and Uli Ulbrich

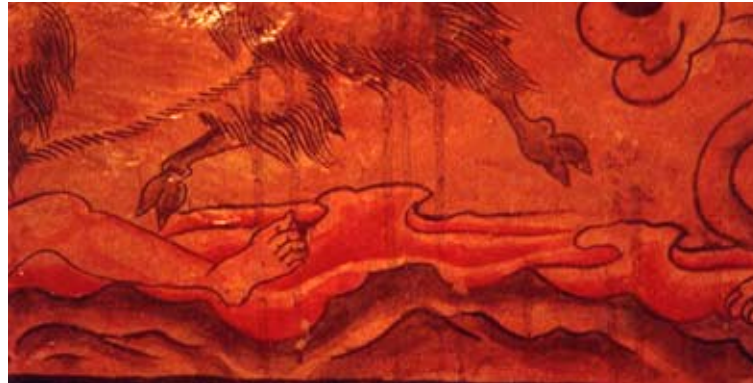
fig. 29: example of damage: striation, dark residue of dirt, pigments and binding agent

Striation

Possible causes:

- water leaking through the roof
- dust in the air settles on the walls

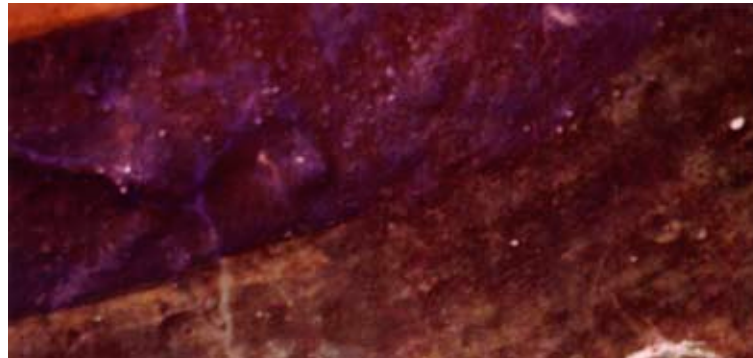
fig. 30: example of damage: discolouration

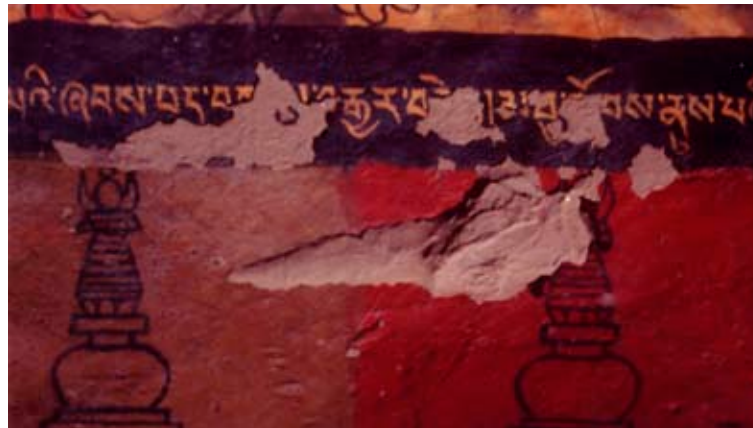
fig. 31: example of damage: losses of plaster and paintlayer

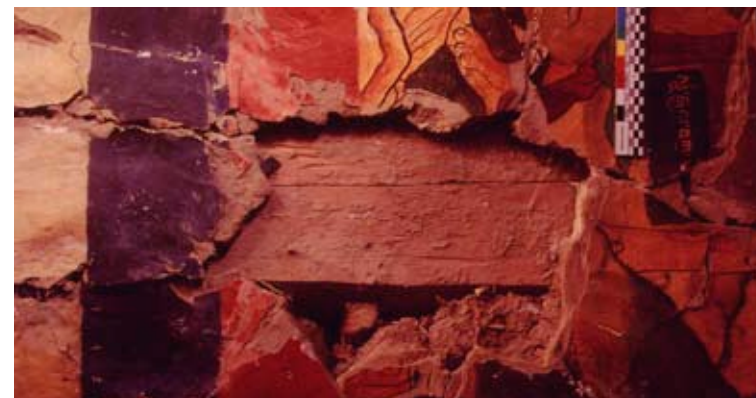
Flaking parts of the paint layer were found at the edges of cracks and losses. But these were still held in place by the Intonaco and by the surrounding paint layer.

In contrast to flaking parts, the loose parts were just held in place by the connected paint layer, but without any fixation to the Intonaco.

fig. 35: example of damage:
flaking and loose paintlayer

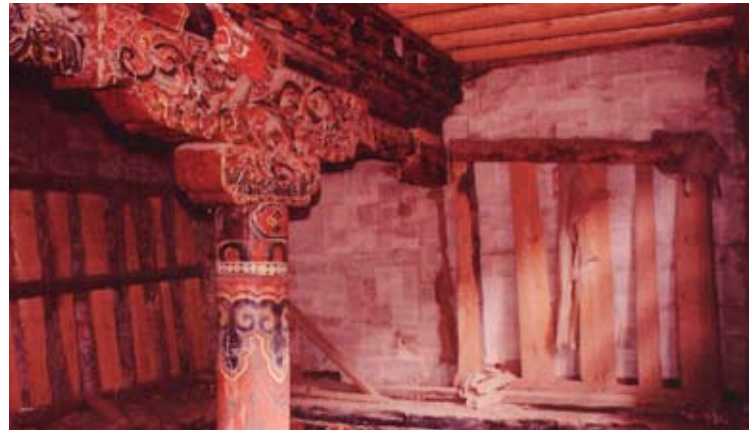
fig. 36: wallpaintings with security layer

- a) clear water, warm, brushed on top
- b) clear water, warm, sprayed on top
- c) water/ethanol (1000ml:60ml), warm, brushed on top
- d) water/ethanol (1000ml:60ml), warm, sprayed on top
- e) strip off in dry condition

At the edges of the walls, the best results could be made by stripping off the gaze layer and then the Japanese paper in dry condition. In cases where the Japanese paper was less well fixed, a bit of water/ethanol-mixture sprayed on top was enough to loosen the fixation to enable removal by hand. A low concentration hide glue was used, apparently partly applied with only little amounts of glue. In the central areas the removal required a great deal of work. Although the gaze layer could be stripped off easily in this section too, the Japanese paper was strongly fixed to the paint layer.

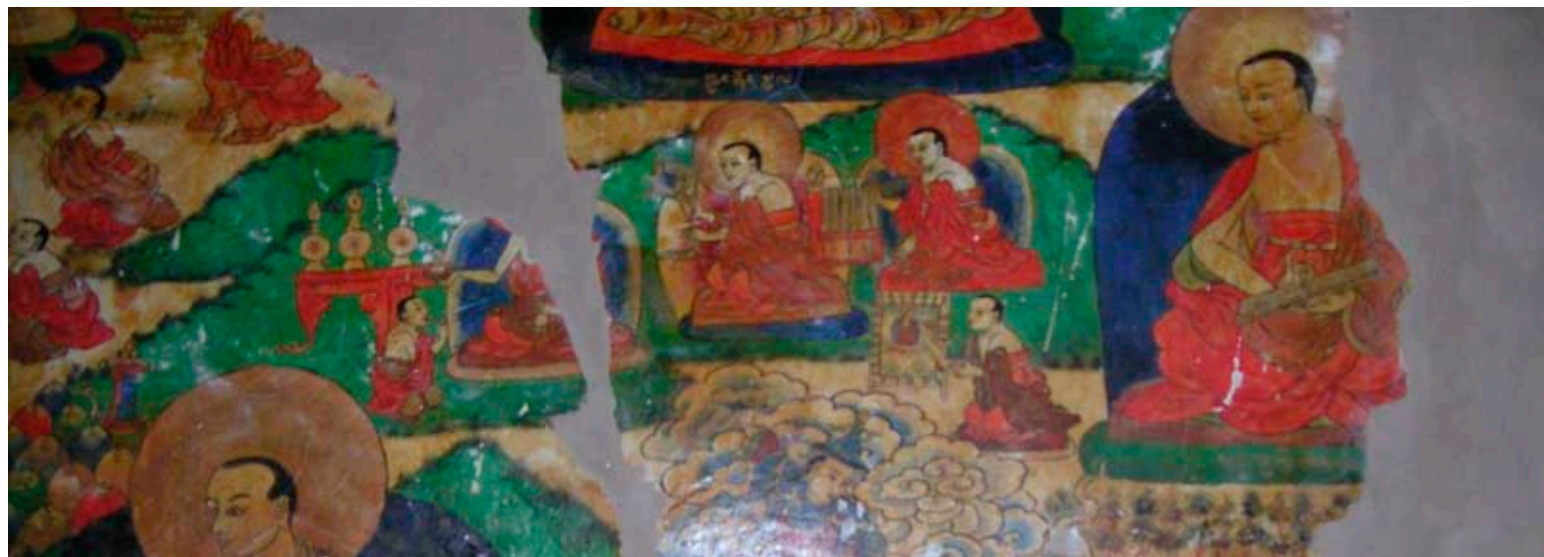
fig. 44: example of fillings, ground floor south wall

- a) opening the cracks by cutting out the brittle mortar without touching the paint layer;
If necessary, removal of old retouchings (if inadequate);
- b) wetting the losses with clean water (best results with anodized water or boiled water);
filling the losses with the repair mortar;
securing the edges of the paint layer by making the fillings higher than the original level (gives safety and stabilization to the edges);

- c) After drying, the surplus of the repair mortar has to be removed with fine brushes or small sponges and water until in-fill and paint layer have the same level, and no painted surface is covered by plaster;
Now the edges are stabilized and fixed.

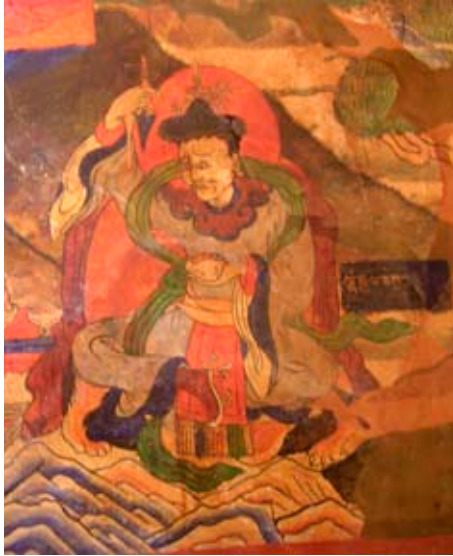
fig. 45 (left): detail, depiction of figure (lha rgyal bkra -) that was optically completed by local-retouching on dress and background

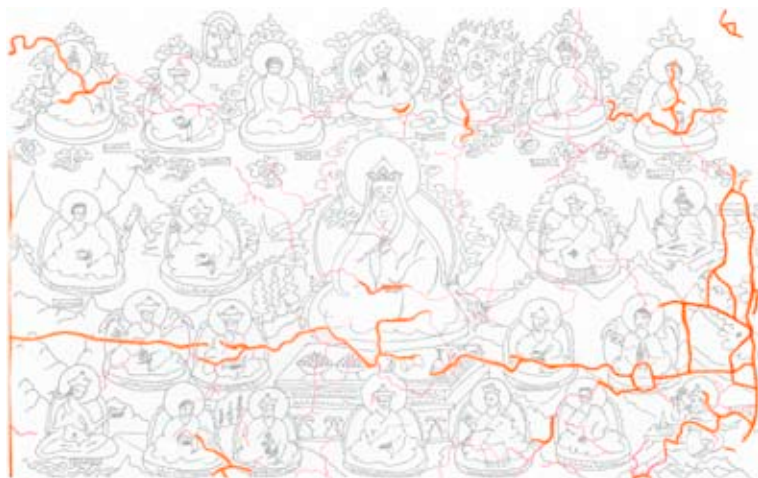
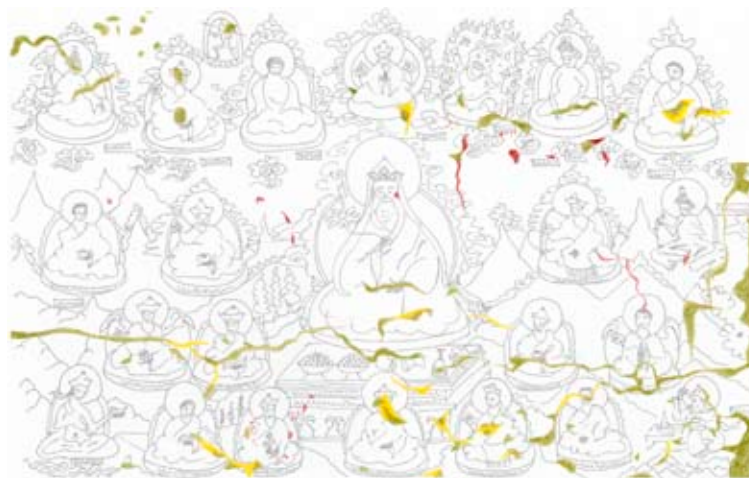
fig. 52..55: painting section 2-1 with analysis of damages

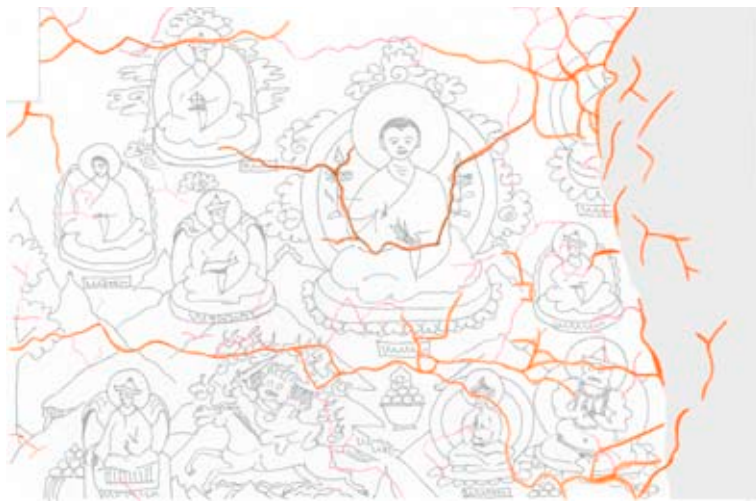
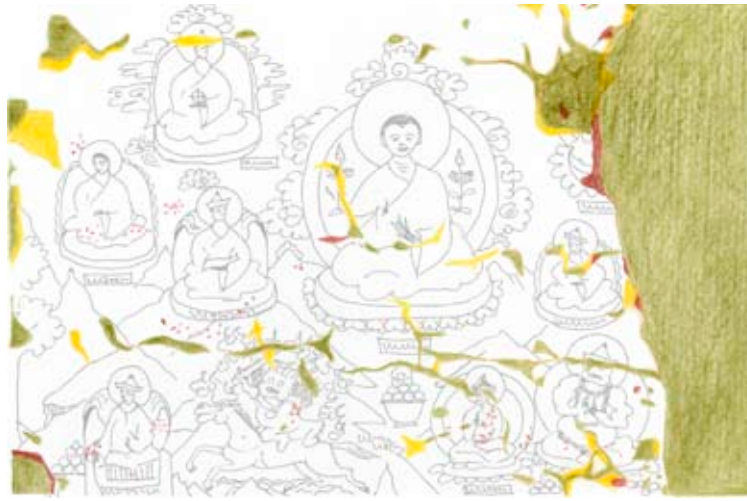
fig. 59..62: painting section 2-2 with analysis of damages

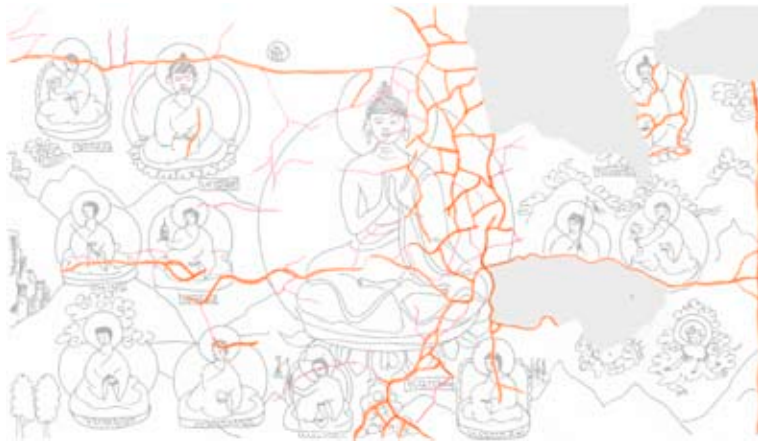
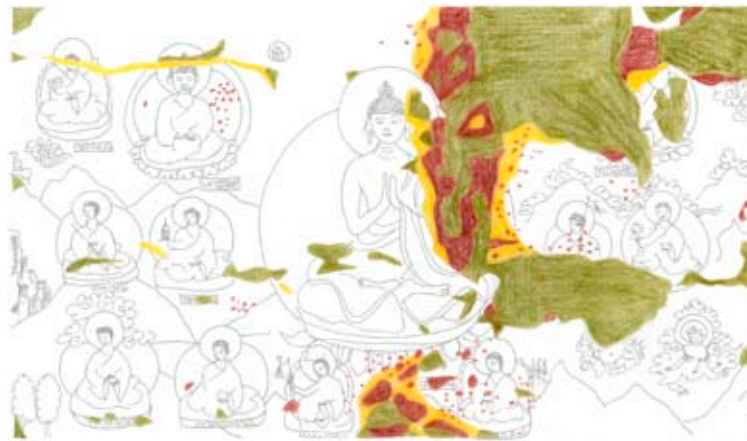
fig. 73..76: painting section 2-5 with analysis of damages

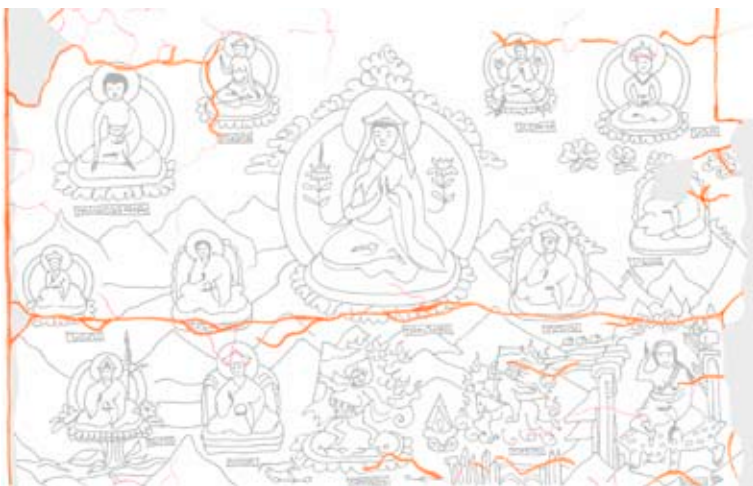
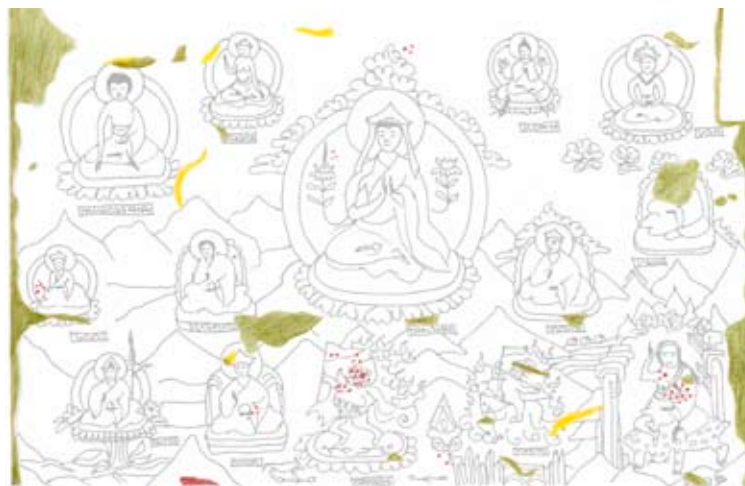
fig. 80..83: painting section 2-6 with analysis of damages

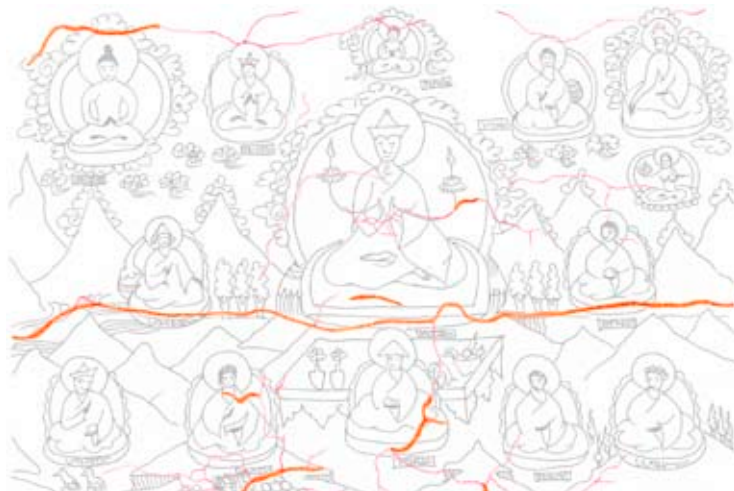
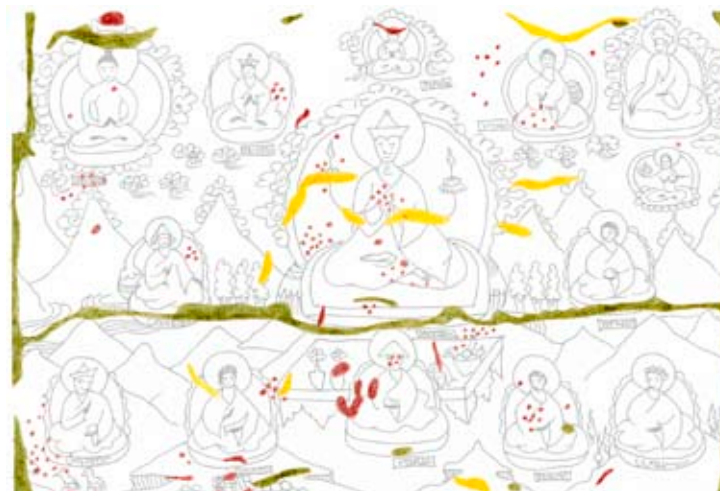
fig. 87..90: painting section 2-7 with analysis of damages

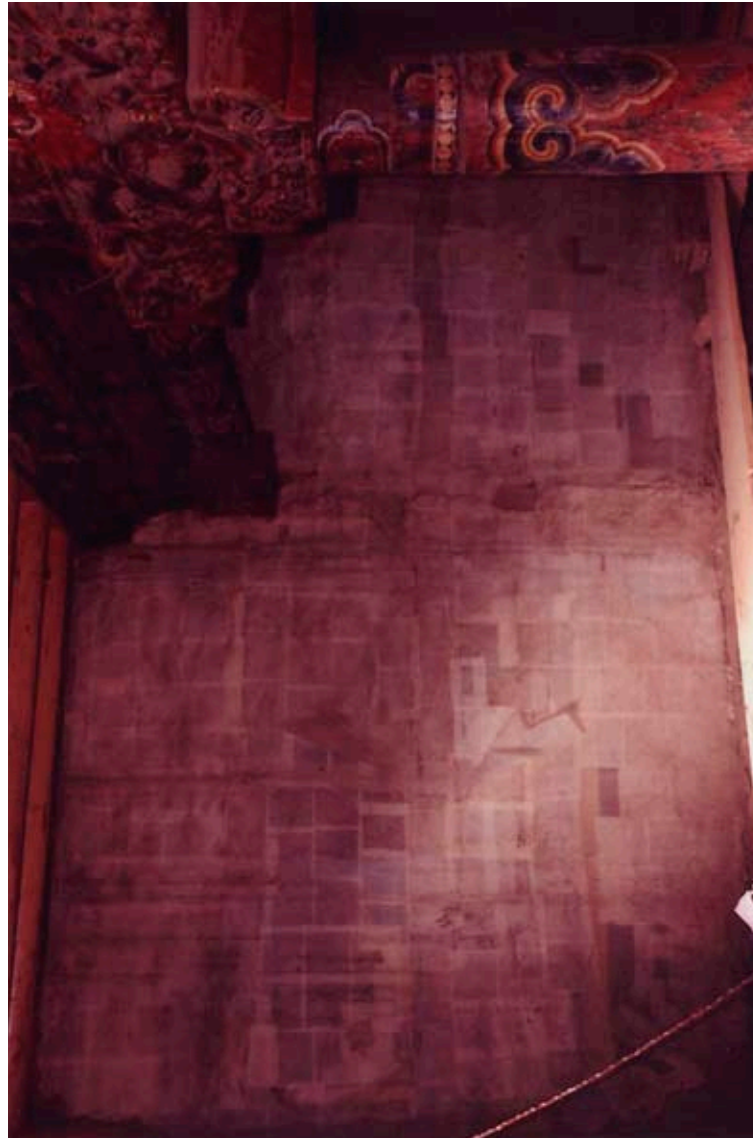
fig. 93 (left): wallsection 2-1 with security layer

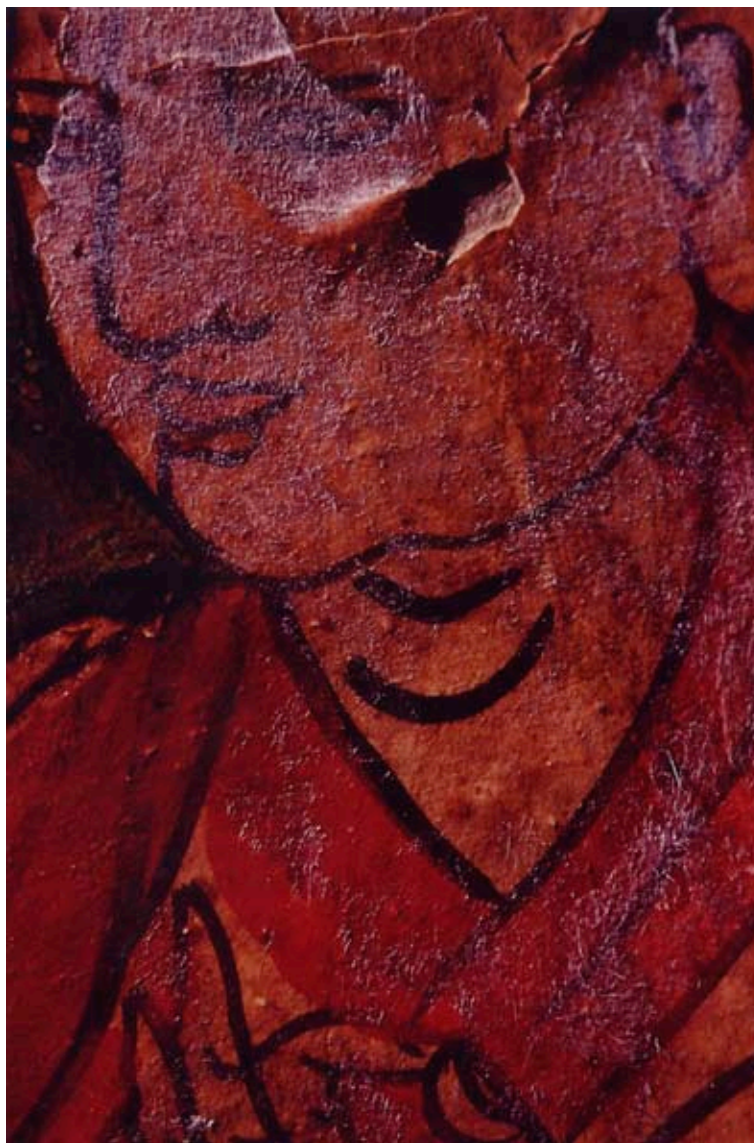
fig. 106 (left): remains of the Japanese paper used for emergency stabilization after the first cleaning

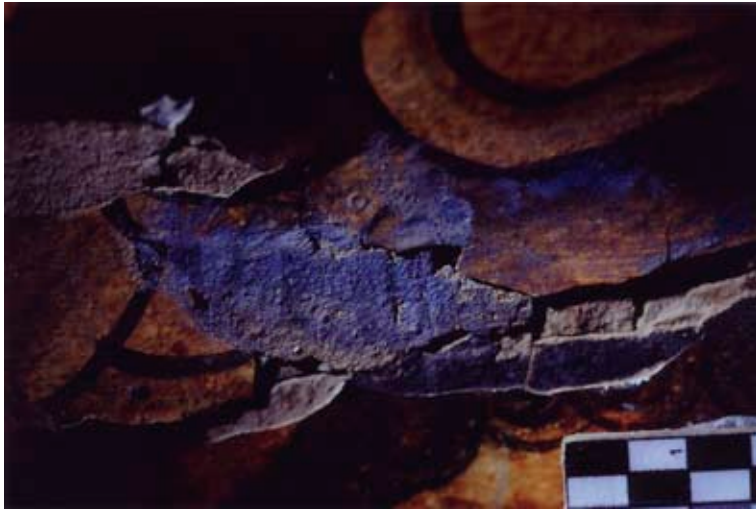
fig. 108 (left): old retouching on an old filling, which was subsequently removed

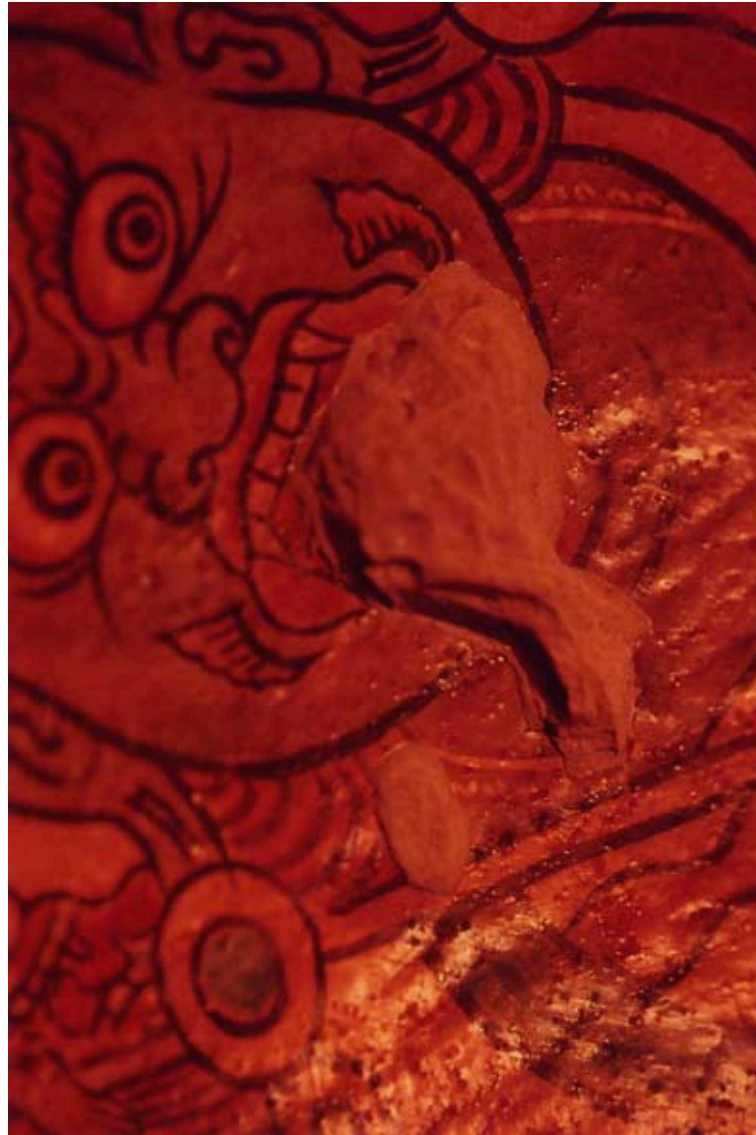
fig. 112 (left): loss of plaster

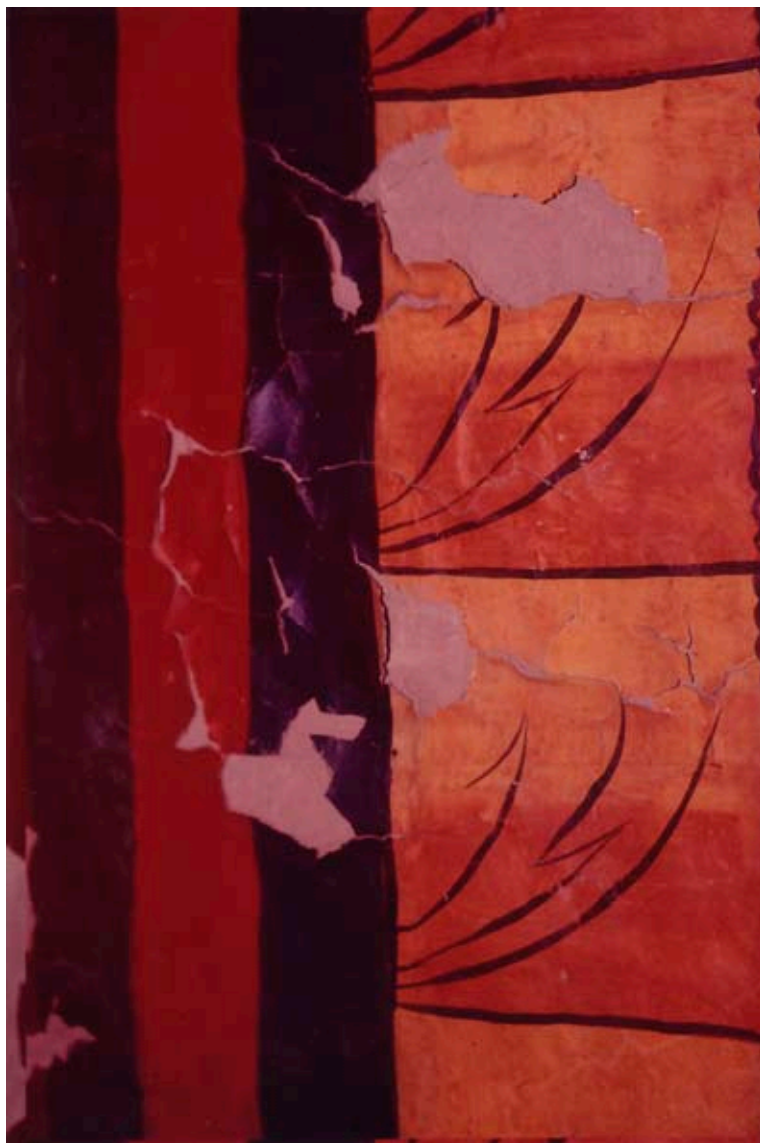
fig. 1114 (left): flaking and loose paintlayer
