A Documentation Report of Achung Namdzong Cave Temple

Namdzung cave temple

The Namdzong cave temple project consists of two different tasks. One is the restoration of the timber frame structure built in front of the caves, which in the past monks have used to access but also to shelter the caves. The second task is cleaning and restoring the historic wall-paintings in three of the caves.

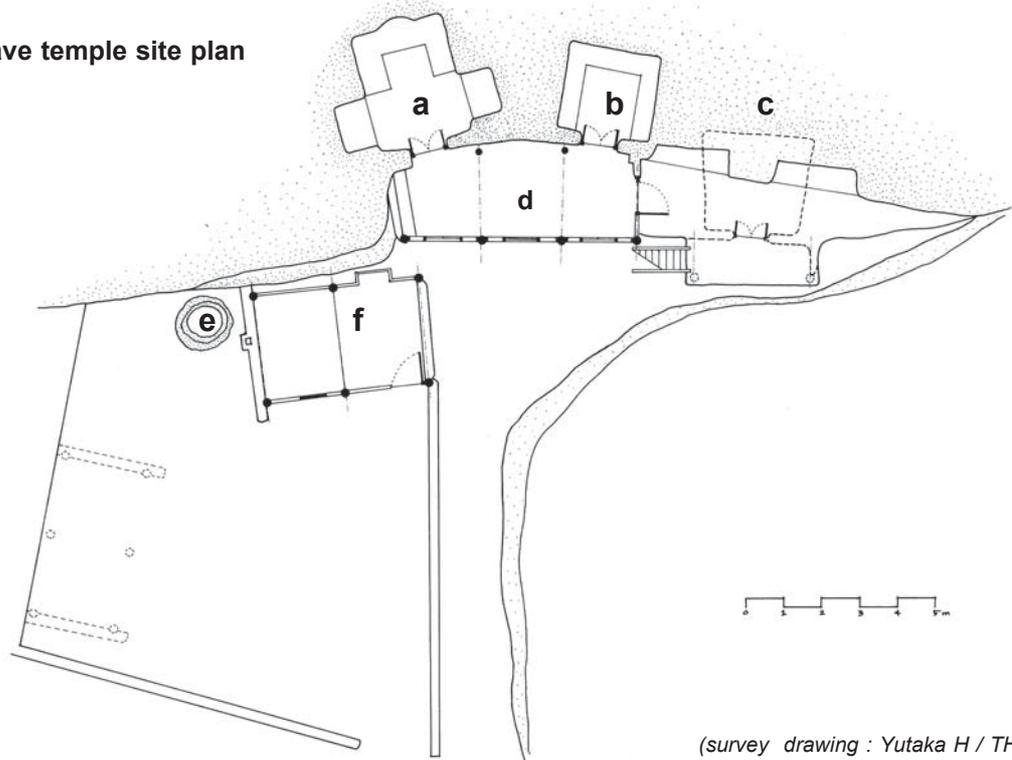
Namdzung cave temple site plan

(survey drawing : Yutaka H / THF)

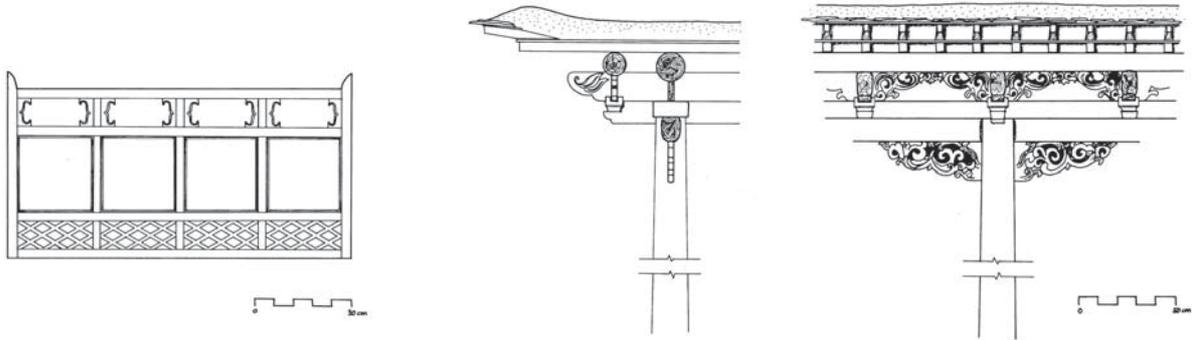
Upper left: New designed railing
 Up: New designed structural order
 Left: Present building facade
 Down left: New designed building facade
 Down: New designed building section
 (survey drawing : Yutaka H / THF)

THF began to refine the plan by working with Tibetan building experts, and taking as reference a local lama's residential building in the same region. Once the restoration plan was fixed, we prepared architectural drawings and calculated the necessary amount of construction materials.

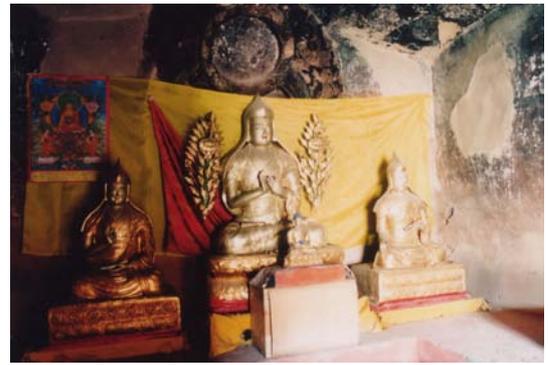
1

1. The frontage of cave no.1, the statues of three Buddhist masters are setting on. Destructive clay work can be seen behind of the main statue (middle). A part of wall plaster has fallen down, and re-plastered by local village people recently.

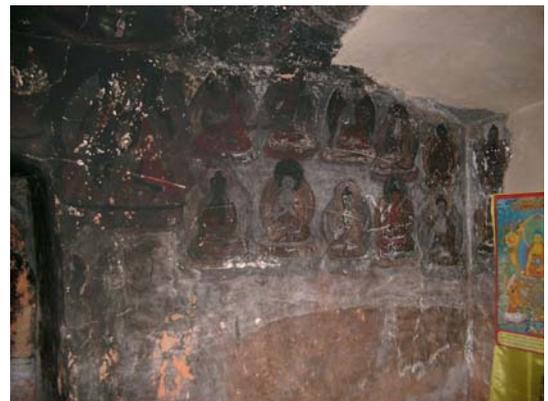
2

2. The wall paintings on the left side of the cave.

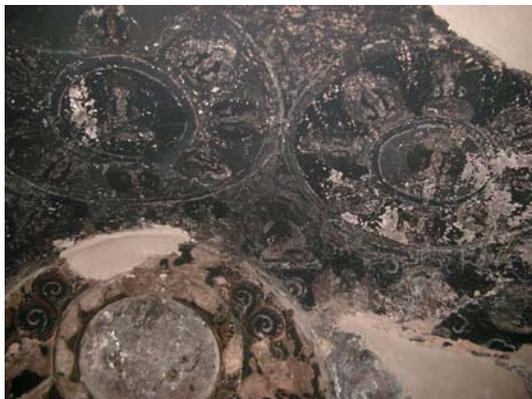
3

3. Details of the clay work and Mandala on the ceiling.

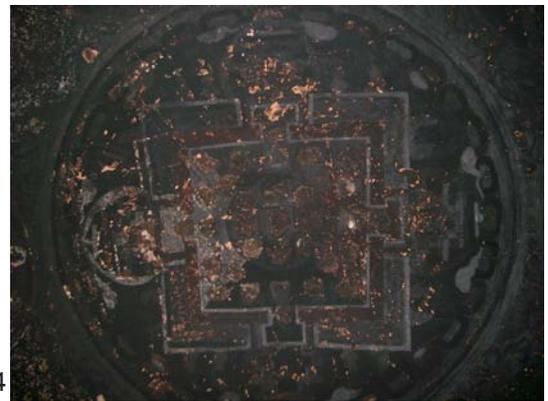
4

The condition of wall paintings are in very poor condition and large parts of plaster has fallen down, many of the original paintings lost already. All wall and the ceiling are blackened by soot and it is very difficult to make out a most of details of the mural without the help of additional light.

4. Mandala on the ceiling, heavily blackened by soot. Partly the gold leaf used in its motifs.

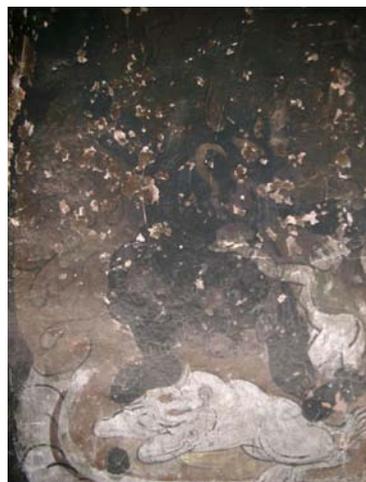
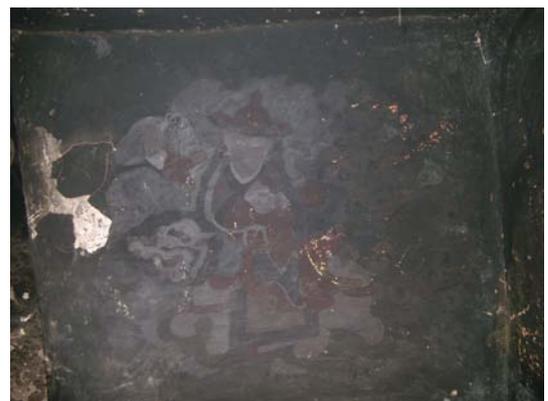
5. 6. Details of painting on wall, covered by soot and partly the paintings are flaking off.

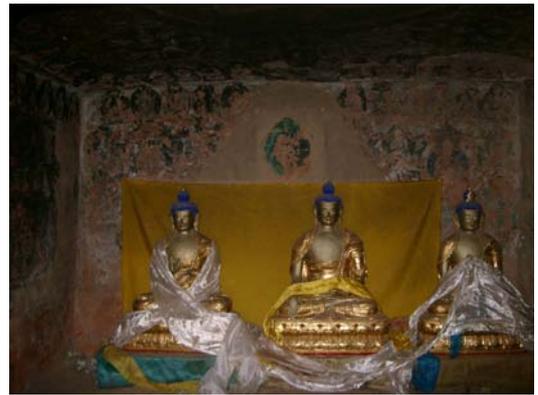
1

1. The front wall of no.2 cave, three Bhuddha images (represent of past, present and future) set on the stage. The plaster on middle has fallen off and re-plastered by local people.

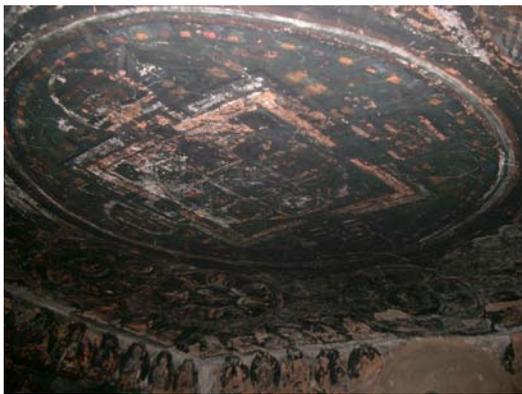
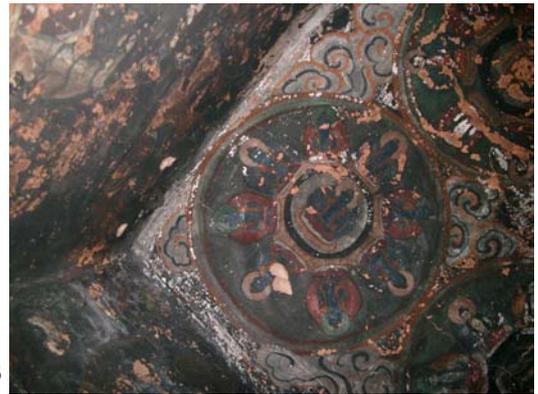
2. 3. There are many Mandra motifs are painted on ceiling, details are mostly possible to trace out, even though coated by soots.

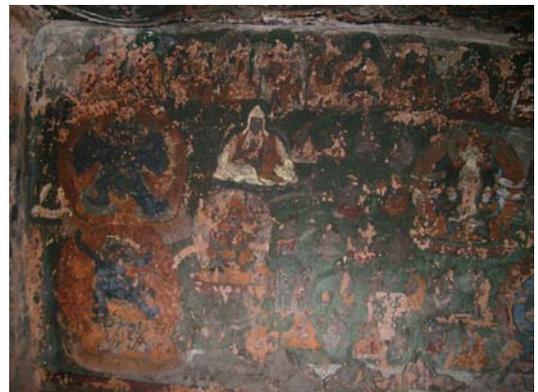
4

4. The right-side of wall paintings, images are clear in general, partly some face of images damaged violently, perhaps its may mede during the Curture Revolution.

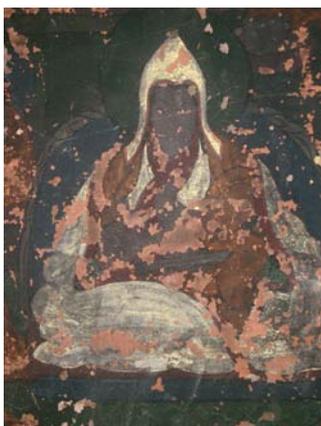
5

5. Detail of an image condition.

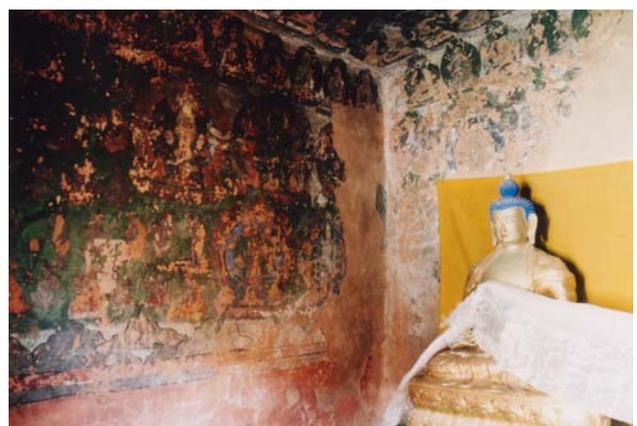
6

6. The left-side of wall shows fraking all over on its surface. A large part of plaster has come off on the coner.

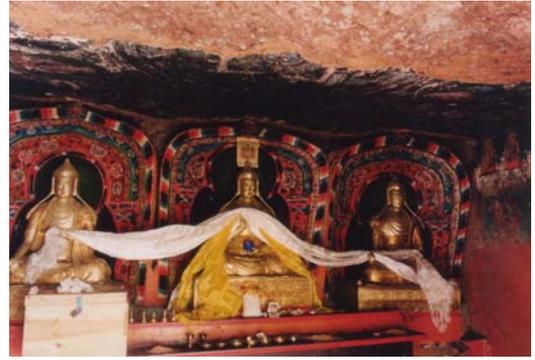
1

1. The frontage of the cave, the three statues are set on the stage.

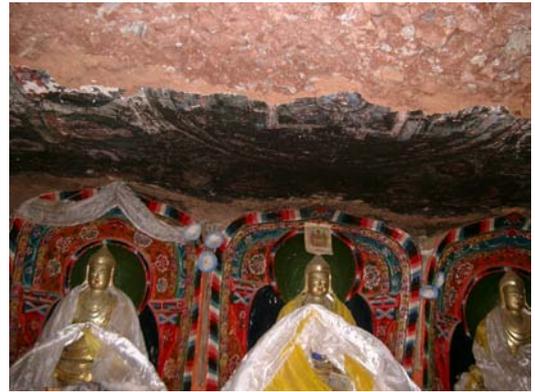
2

The ceiling of this cave is badly damaged. Moreless the half of area is completly missing down to the bedrock. The remaining ceiling is very blackened and flaked and show many cracks.

2. A big area of ceiling fallen down. The bedrock is sandy and round gravels are consisted in it. Finding a sweatest plaser with this erath condition will be necessary for mural restore.

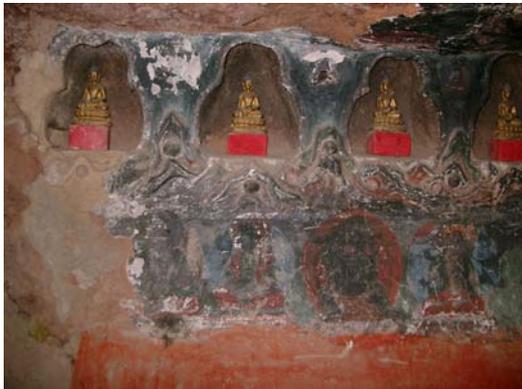
3

3. The left-side wall, there are eight small openings for small statues. And they are framed by fine cray work decorations. The paintings are less-blackened and clear, even some crack on it, but less flake out in whole.

The right-side wall also similler condition as left-side.

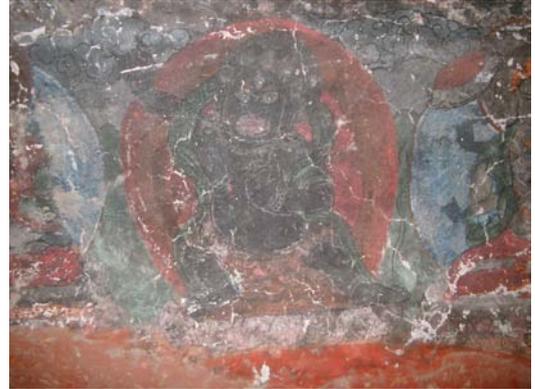
4

4. A detail of the painting, small crack can seen on it.
