# The Monastic Compound of Nyarma as a Case-Study for the Conflict between the Needs of Modernization and Conservation

Gerald Kozicz

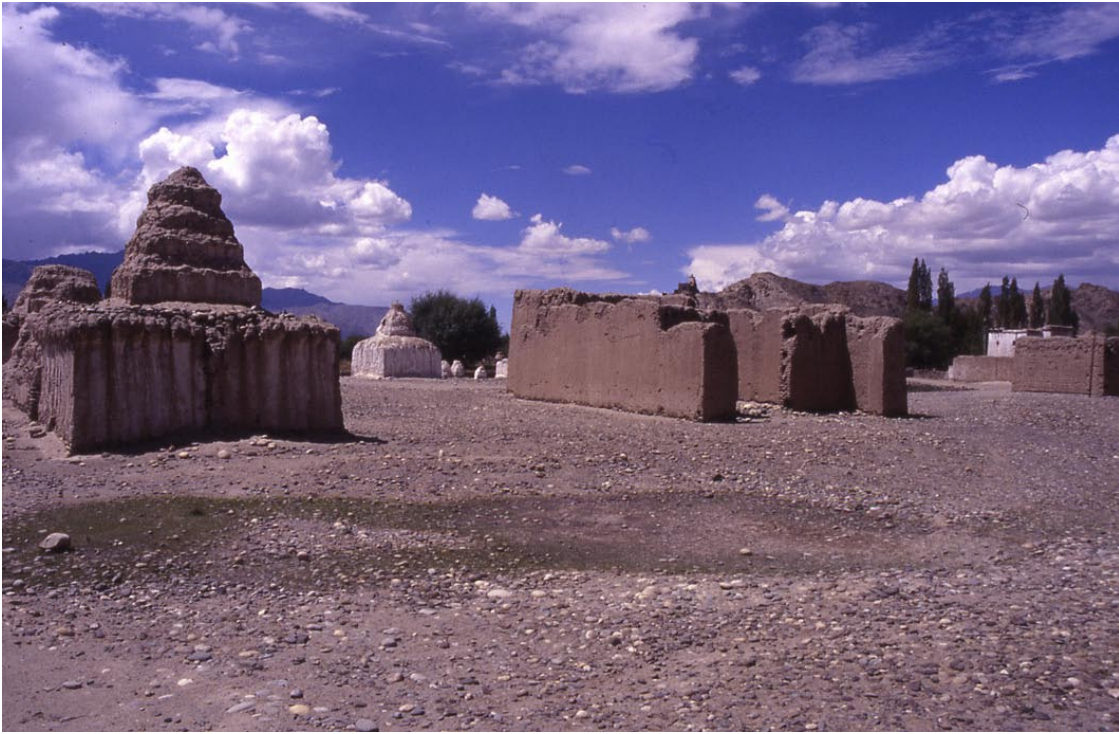
Pl.1: Ruins inside the sacred compound (2002). The castle is in the background.

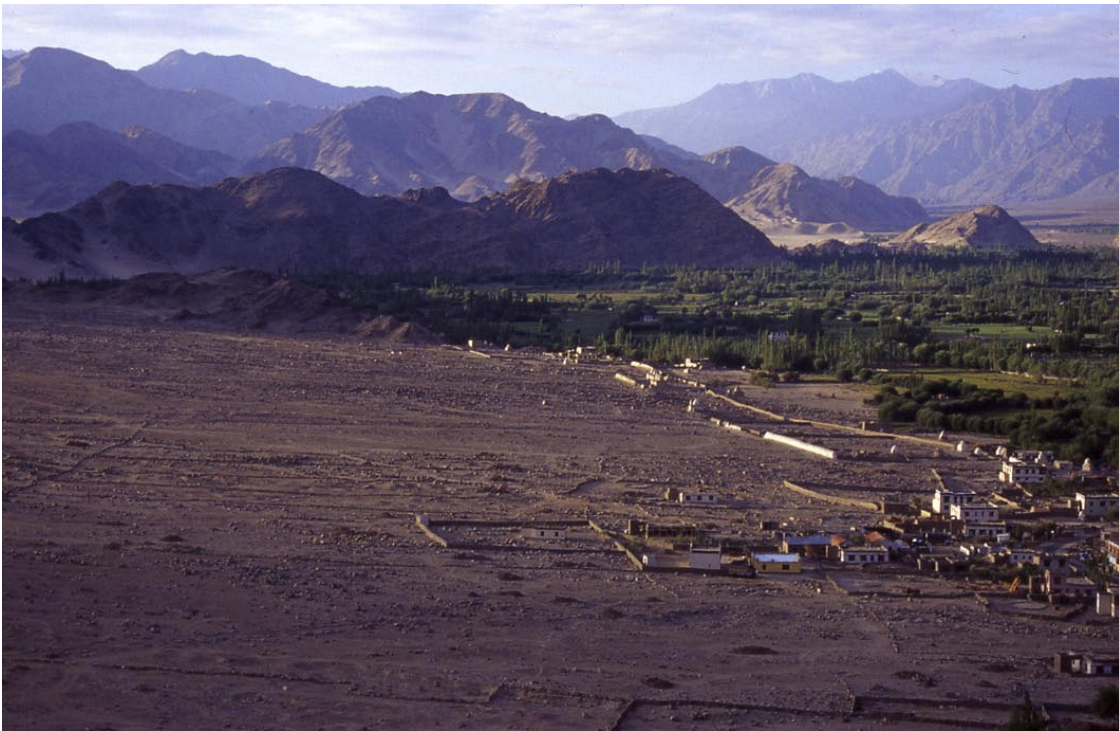
Pl.2: The northern section which is part of the Tikse community area.

As a consequence of the mere absence of artefacts it has been widely ignored by the scientific community that both the area of the former monastic compound as well as the northern sector, today integrated into the Tikse community area, have come under pressure by the various interests caused by new developments in the fields of tourism, agriculture and different kinds of building activities. The photographic documentation from 2002 already shows the “besiege” of the compound by the new agricultural activities on the basis of new irrigation technologies. A similar situation emerged in the northern sector. Since the historical importance of this area has been completely ignored so far the situation is even worse there. Today new boundary walls cut through the area, disturbing the former order of the relics (pl. 2). One of those walls even passes along the former main wall of one of the temples. Most of the area has obviously been designated for the purpose of new housing. The invaluable murals of the stupas are still lacking any protection against the on-going vandalism by the children of the local community. Many of the murals were either scratched off or withewashed during the last twenty years and the ground floor of one of the stupas is obviously used as a goat-shed (pl. 3).

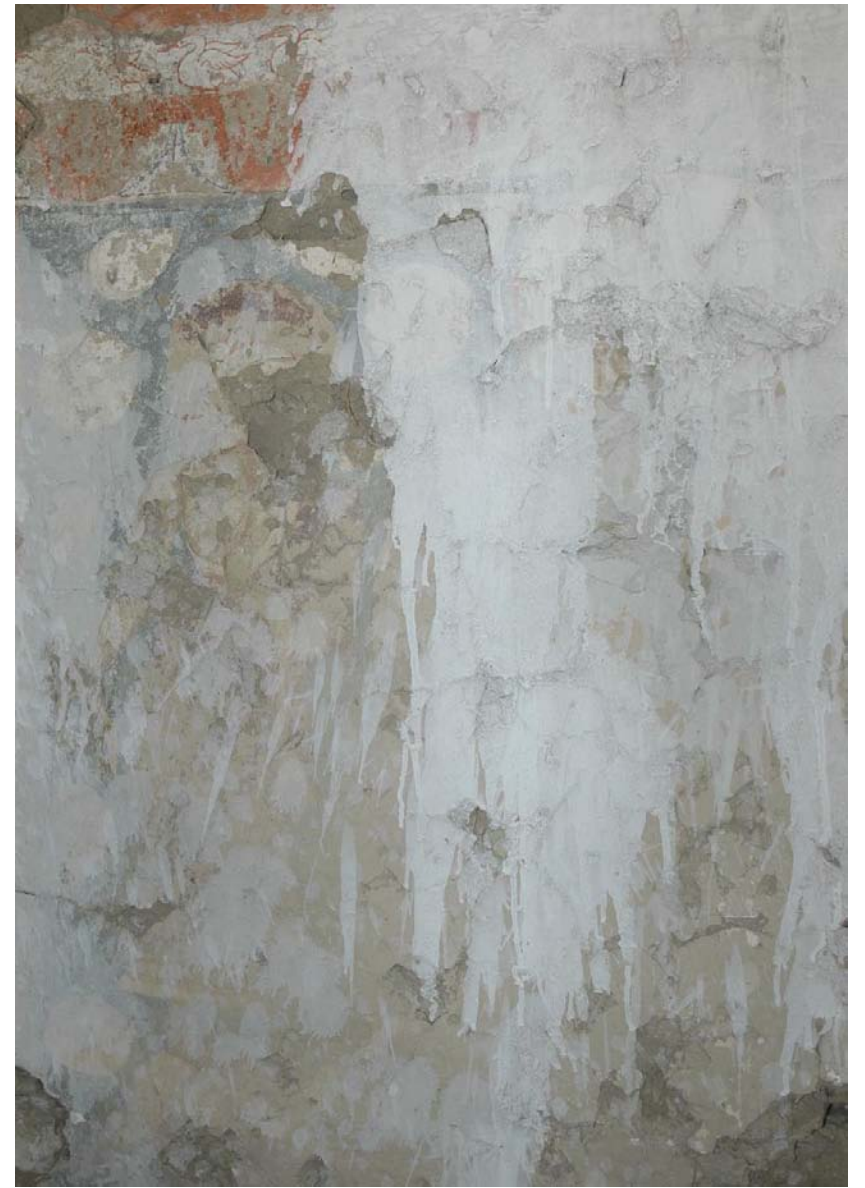
Pl.3: Whitewashed mural inside of one of the stupas (Mchod-rten) of the northern section.

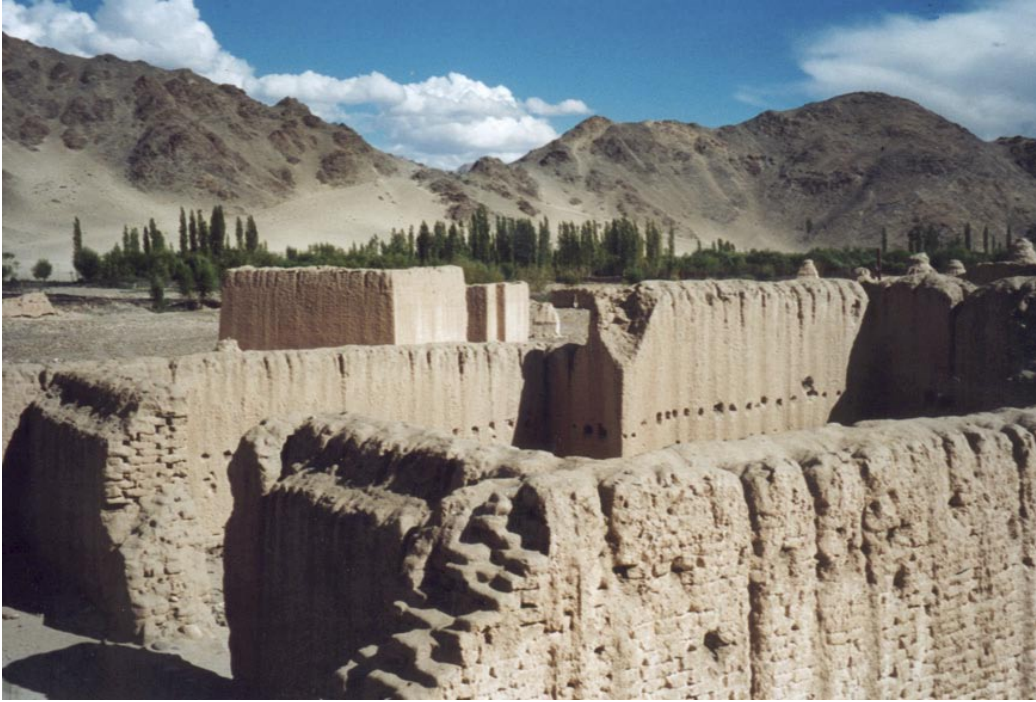
P1.5: The large ruin of the un-completed Temple next to the NMT. (Marianne Pecnik)

Archaeological evidence for a later dating of this ruin is also provided by its significantly thicker walls which measure 132 cm. The fact that it does not show traces of any exterior plaster is another strange feature of this building which actually can only be speculated about. The most proper explanation would be that it had never been finished. (pl. 5)

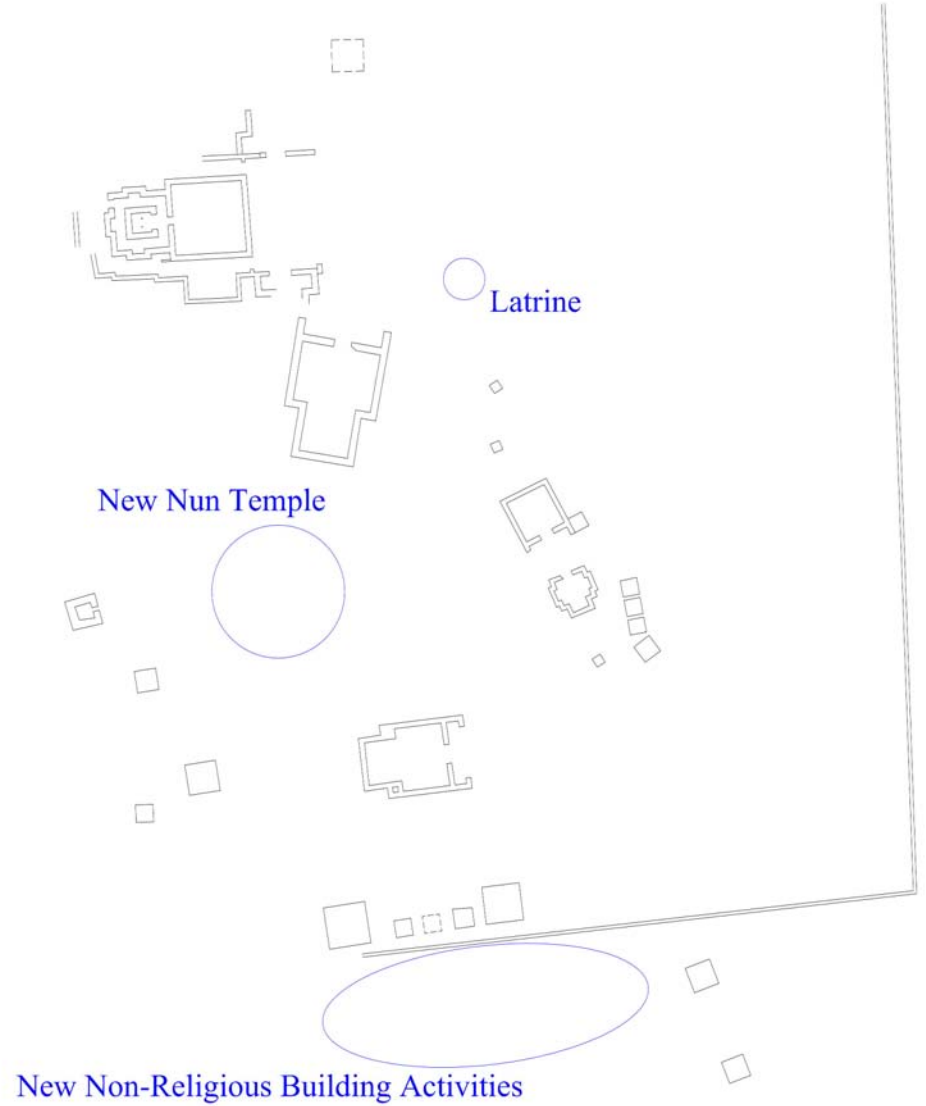
Pl.10: Site map showing the areas of recent construction and building activities inside and around the compound.
