THF WORK REPORT JYEKUNDO OLD TOWN RECONSTRUCTION 2011

## RESTORATION OF KARTSOG LHAKHANG

## ARCHITECTURAL SURVEY

# STRUCTURAL INTERVENTION

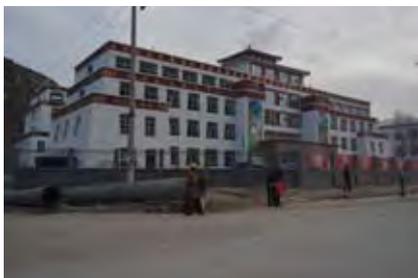
2

**New hospital building 2**

As all the buildings, this hospital is constructed with a steel reinforced concrete frame filled with cement bricks. The locally traditional structural slope of the building was imitated in cement masonry, cutting the bricks into shape. Lastly everything was painted, applying some local designs.

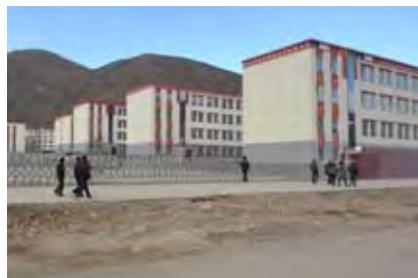
4

**Middle school 4**

The construction of middle and elementary schools was mostly completed this year. The buildings are still vacant and are intended to be operated next year.  
lower picture: construction of 80 m<sup>2</sup> residential houses in process.

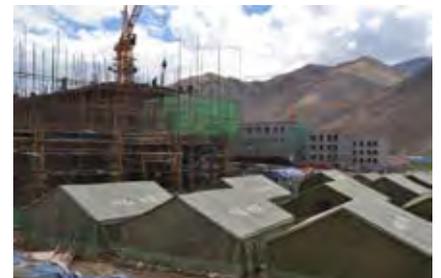
6

**Workers tents 6**

Countless migrant workers from other Chinese provinces have come to Jyekundo working on the countless construction sites in town.

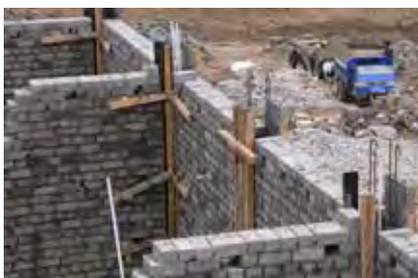
- Elementary school, October 2011 1
- Cement masonry, July 2011 3
- Construction of 80m<sup>2</sup> houses, August 2011 5
- Reinforcement steel preparation 7

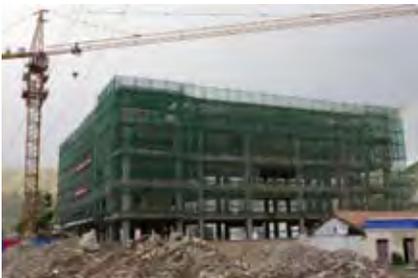
2

**Steel reinforced concret frame building 2**  
All buildings use the same construction technique.

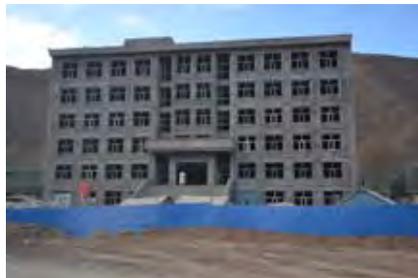
4

**Hospital 4**  
Several brick factories were constructed in town to provide an immense supply of cement bricks for the reconstruction.

lower picture: cement bricks laid out to dry

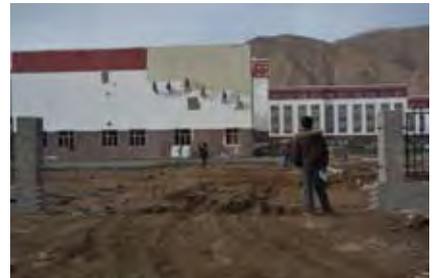
6

**Elementary school 6**  
The building is completed. Now paint is applied to the exterior.

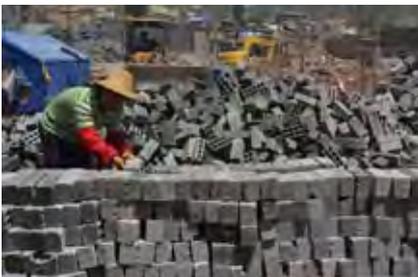
- 1 Construction of 80m<sup>2</sup> houses, August 2011
- 3 Workers piling up cement bricks
- 5 Fabrication of cement bricks
- 7 A neighbourhood tent settlement, June 2010

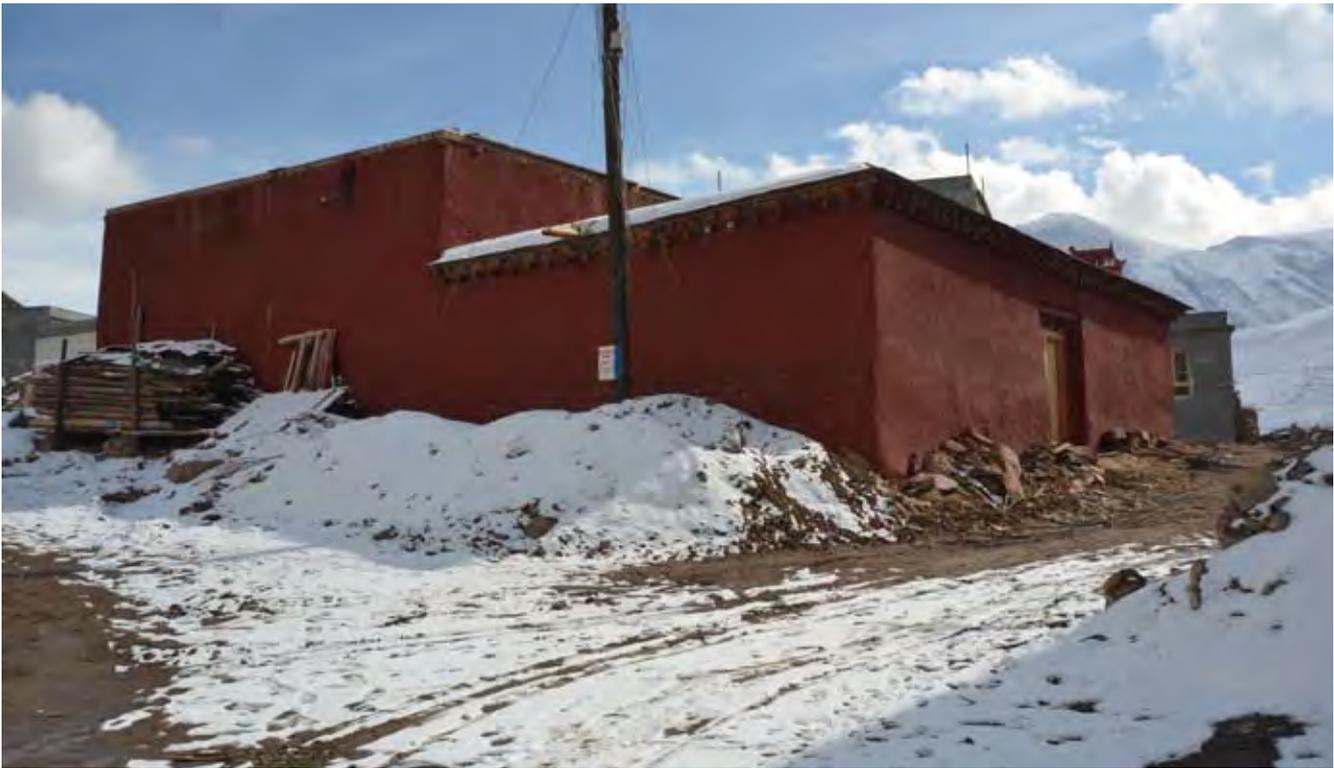
The temple is decorated with historic wall paintings in the entry and in the main hall. In the entry are depictions of the kings of the four directions. In the hall, there are Sangye Menlha surrounded by thirty-seven gods on the right, and Sakyamuni surrounded by the sixteen Arhats on the left. The paintings were made with traditional (both natural and synthetic) pigments and animal glue binder on earthen plaster on rammed earth walls. Before the earthquake, the paint layer of the compositions in the entry was already damaged and needed restoration work. Since, the need of a conservation work has increased drastically. One square meter of painted surface had fallen to the floor after the earthquake impact. They have been collected, stored in boxes and where possible refitted on the wall.

We found that fifty percent of the plaster was detached. To stabilize the paint layers again was the most urgent work. The team choose an appropriate method using natural gluing earthen grouting, which was be injected between the plaster and the wall. This method has been developed especially for the Katsu Lakhang following the method for the famous paintings of Dunhuang as well as previous THF projects.

The cracks were then filled with a material based on the original plaster consistency. Finally the paintings were cleaned.

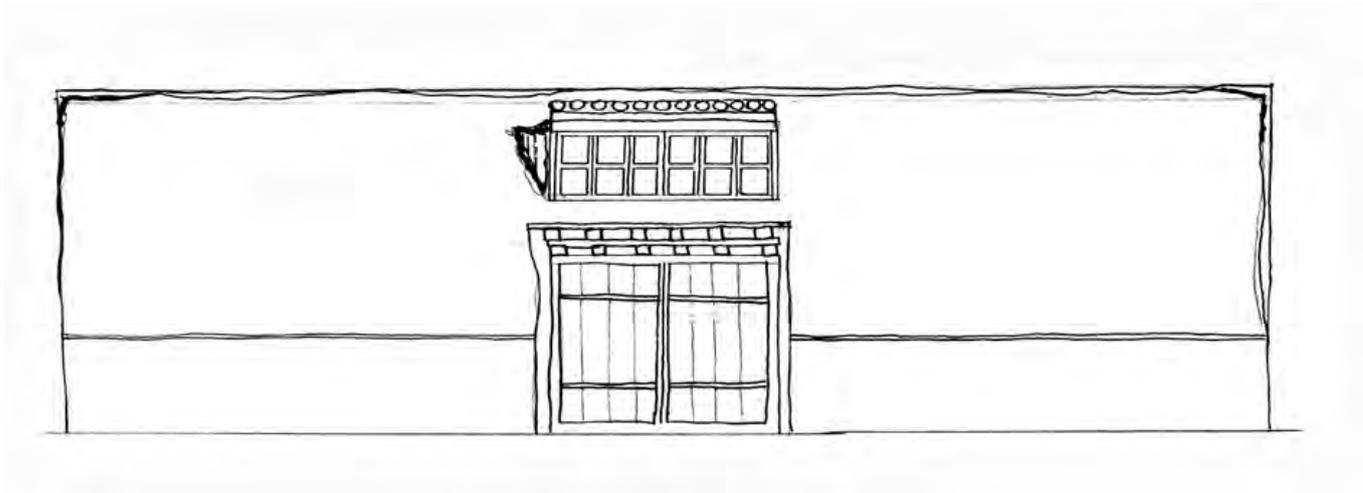
11 Main hall entry, south elevation, Autumn 2004  
Measured drawing by Liang Yaqin.

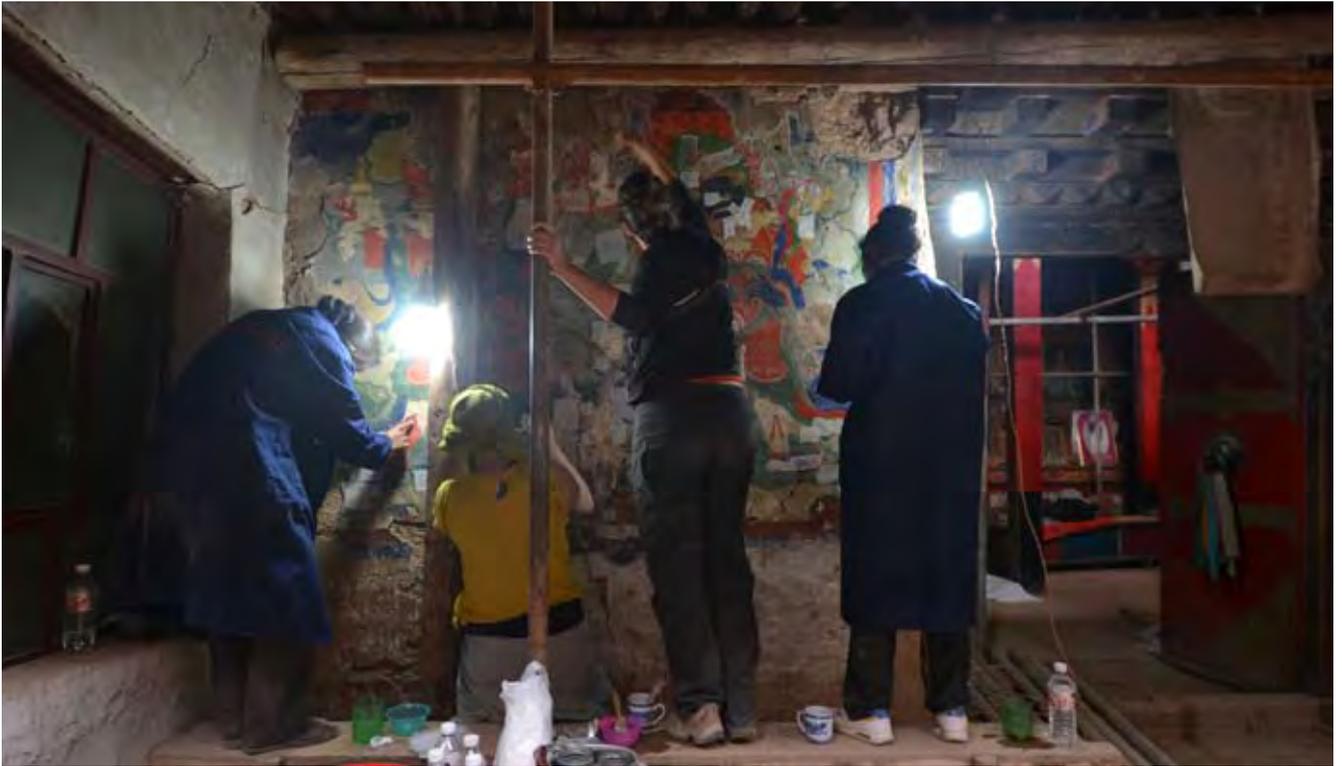
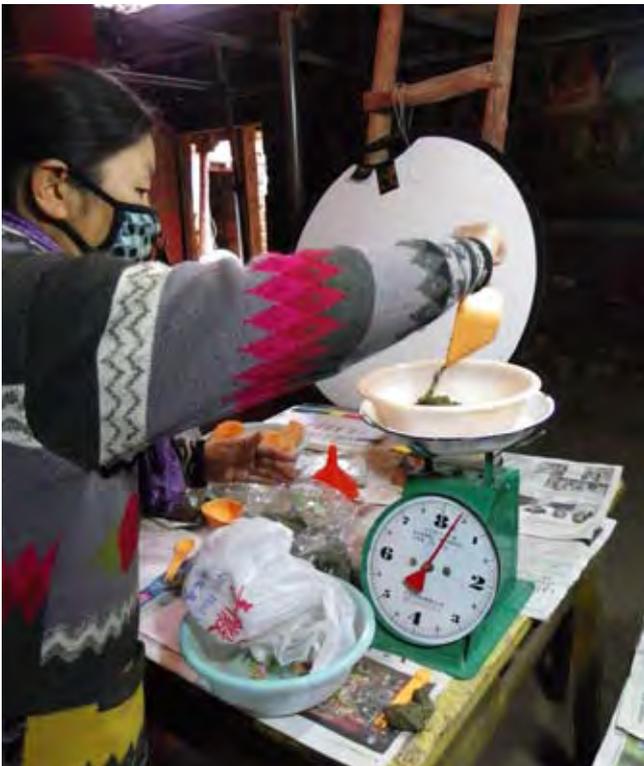
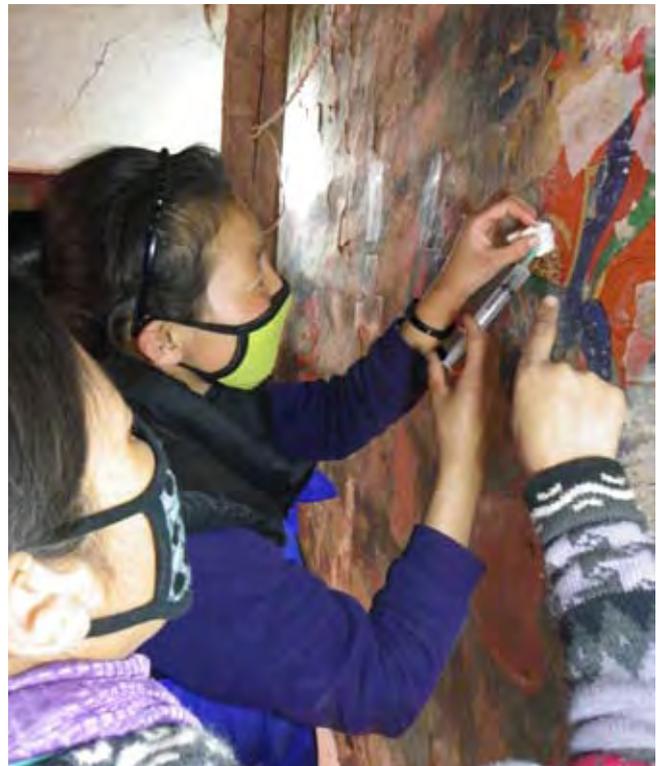
Conservation team working in the entry hall 1  
Trainees are conducting earth sample tests 2  
Local conservation trainees are executing consolidation injections 3

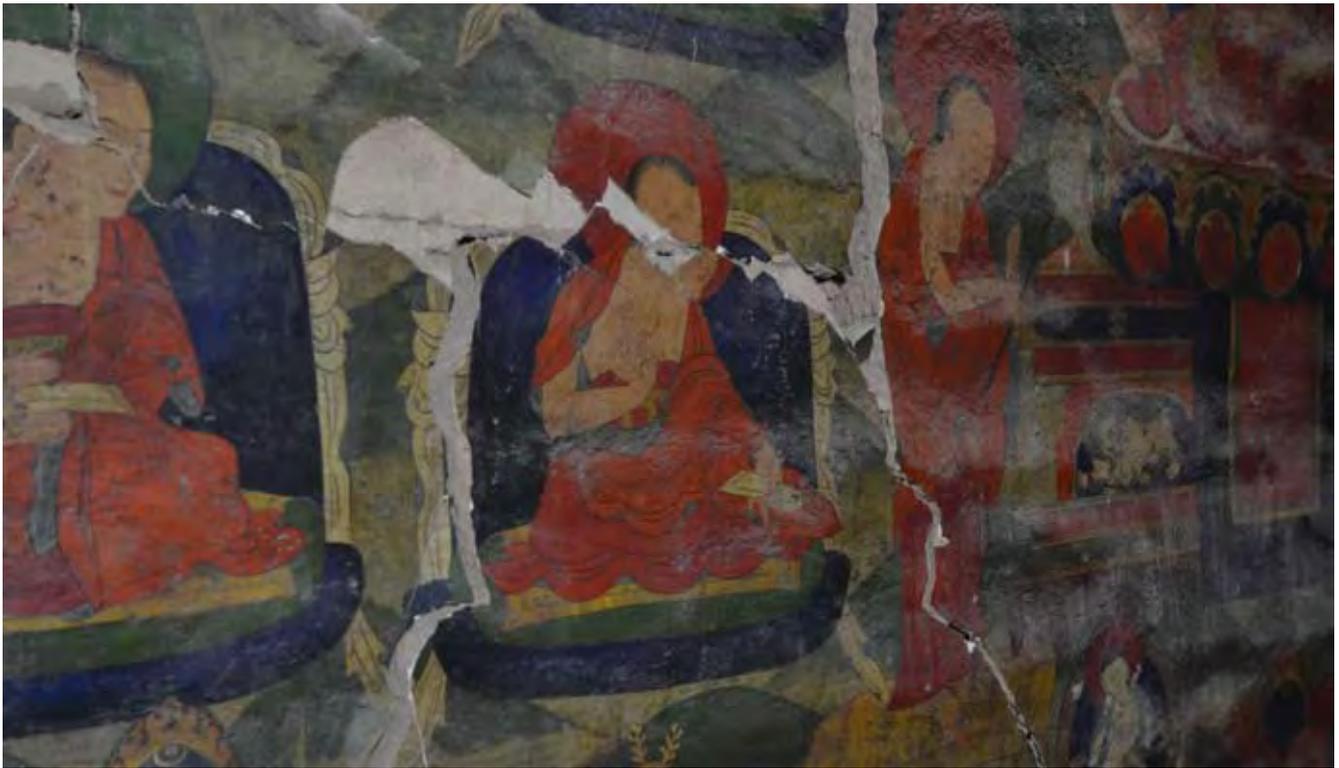
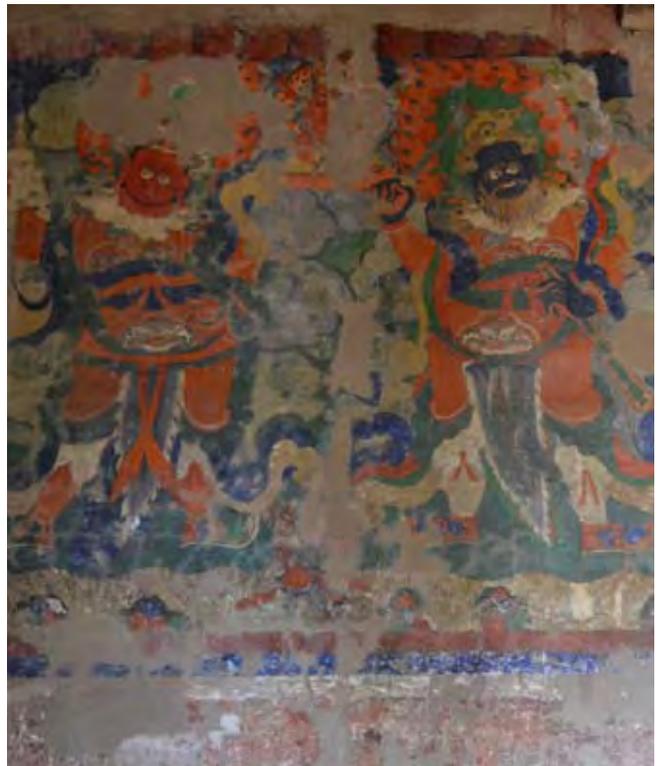
- 4 Damaged painting inside main hall
- 5 Earth sample tests
- 6 Temporary consolidation with paper
- 7 Painting after urgent consolidation work

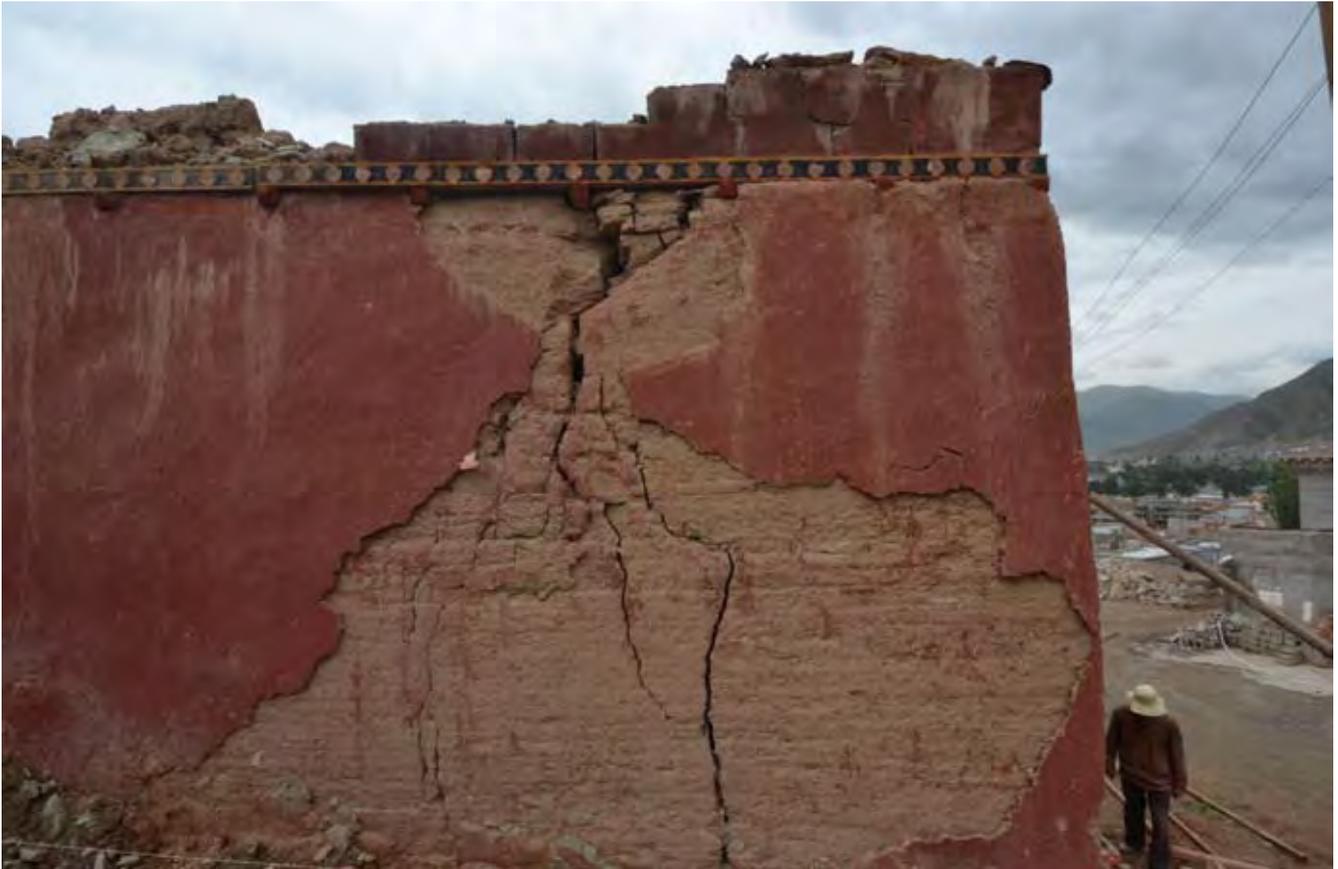
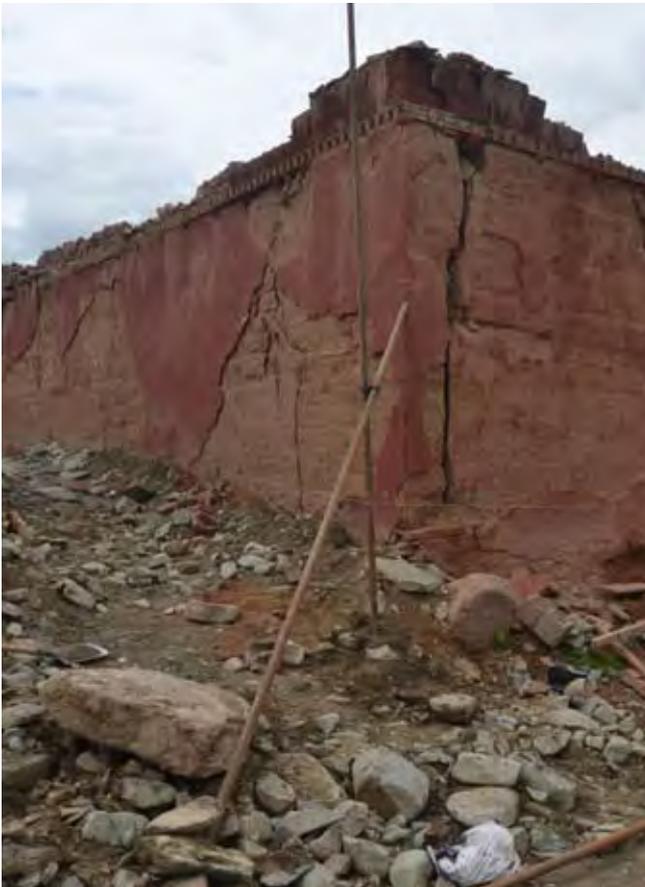
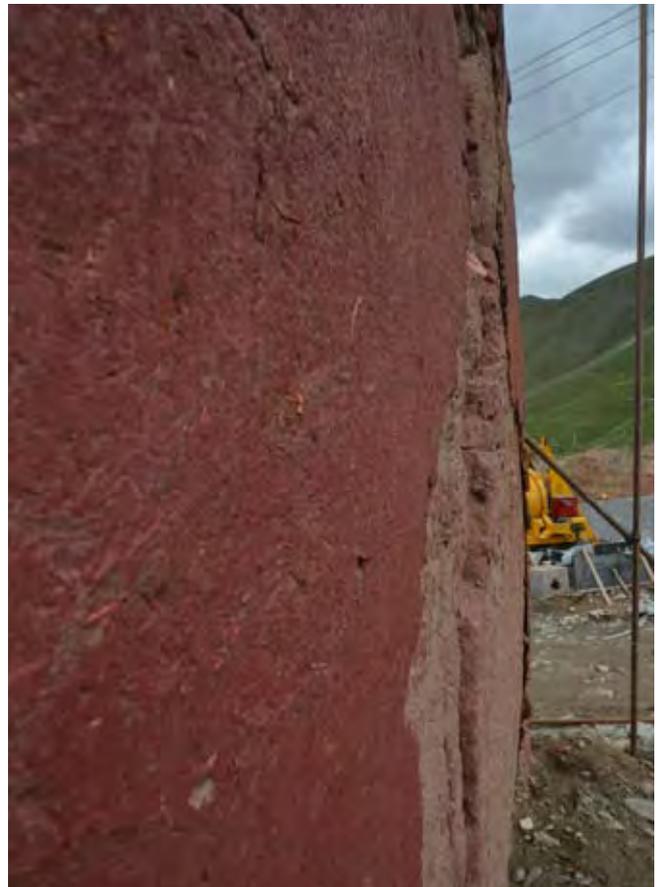
## STRUCTURAL DAMAGE

The north west corner was the most severely damaged part.

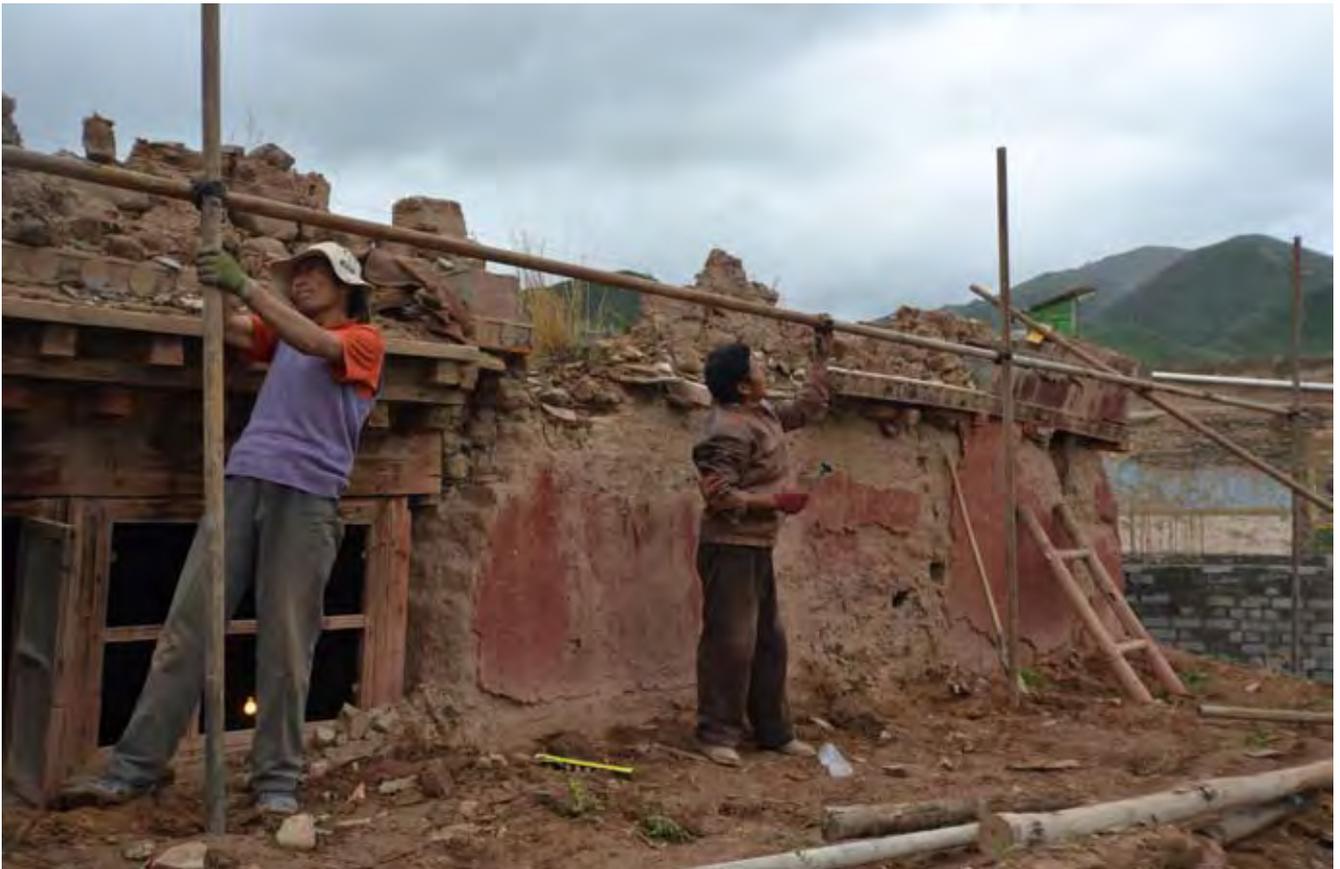
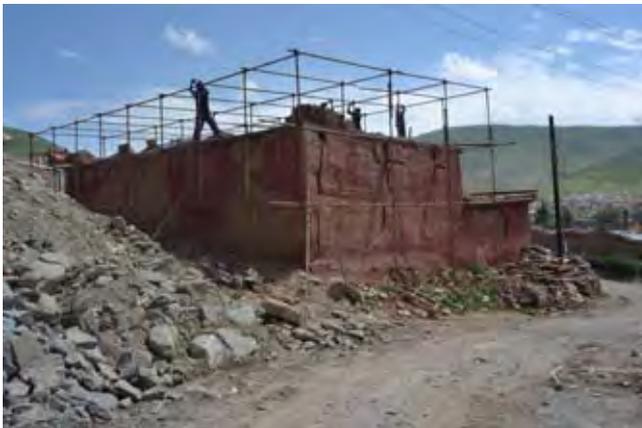
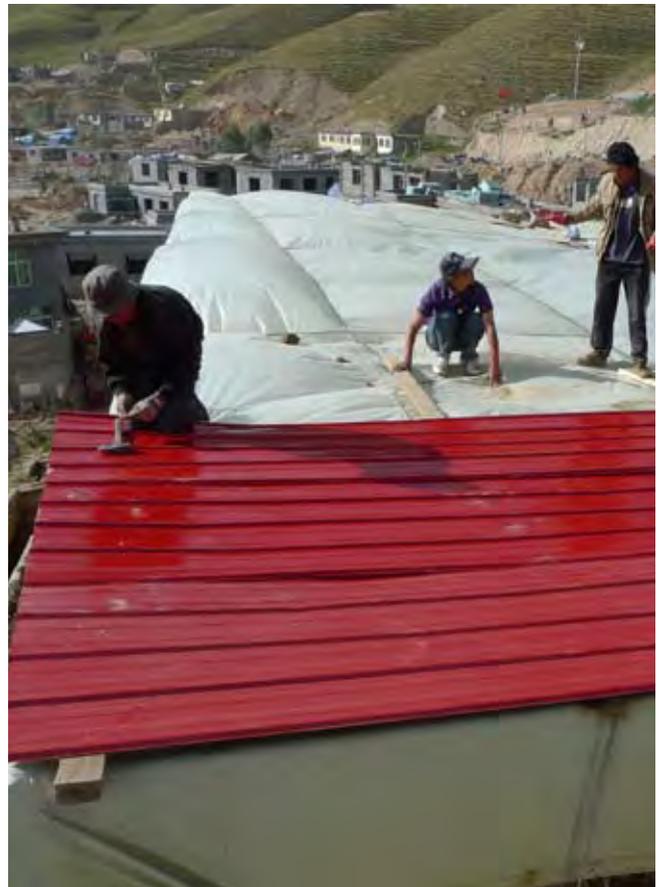
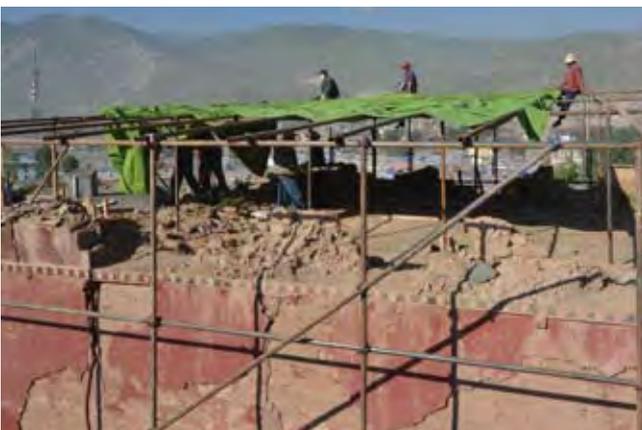
## TEMPORARY ROOF

The team rented metal scaffolding and erected a temporary roof to prevent water leakage while the wall-paintings were being restored.

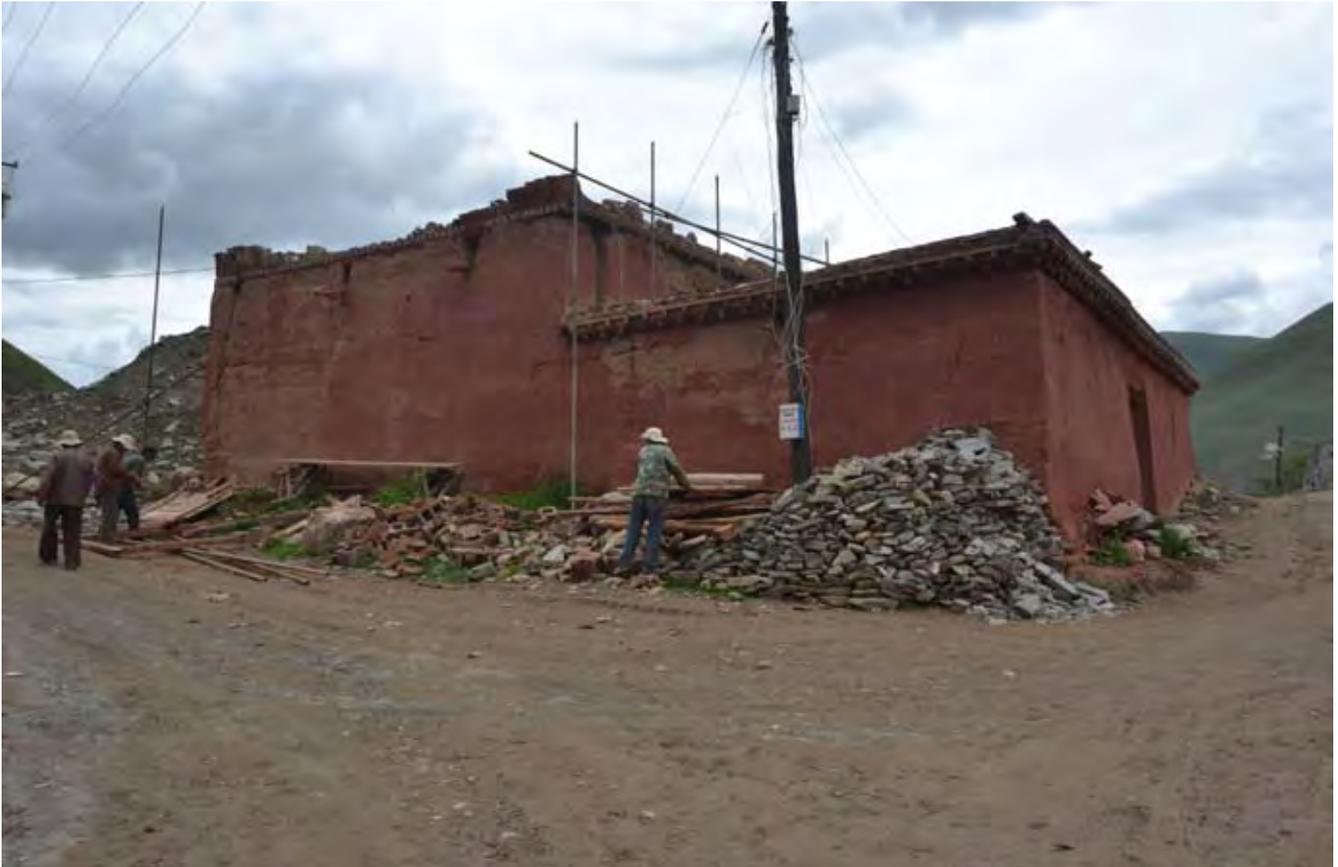
An 18 x 12 meter cloth was made to cover the temple. This was covered with light metal roof sheets, enabling extensive roof repairs without exposing the wall-paintings.

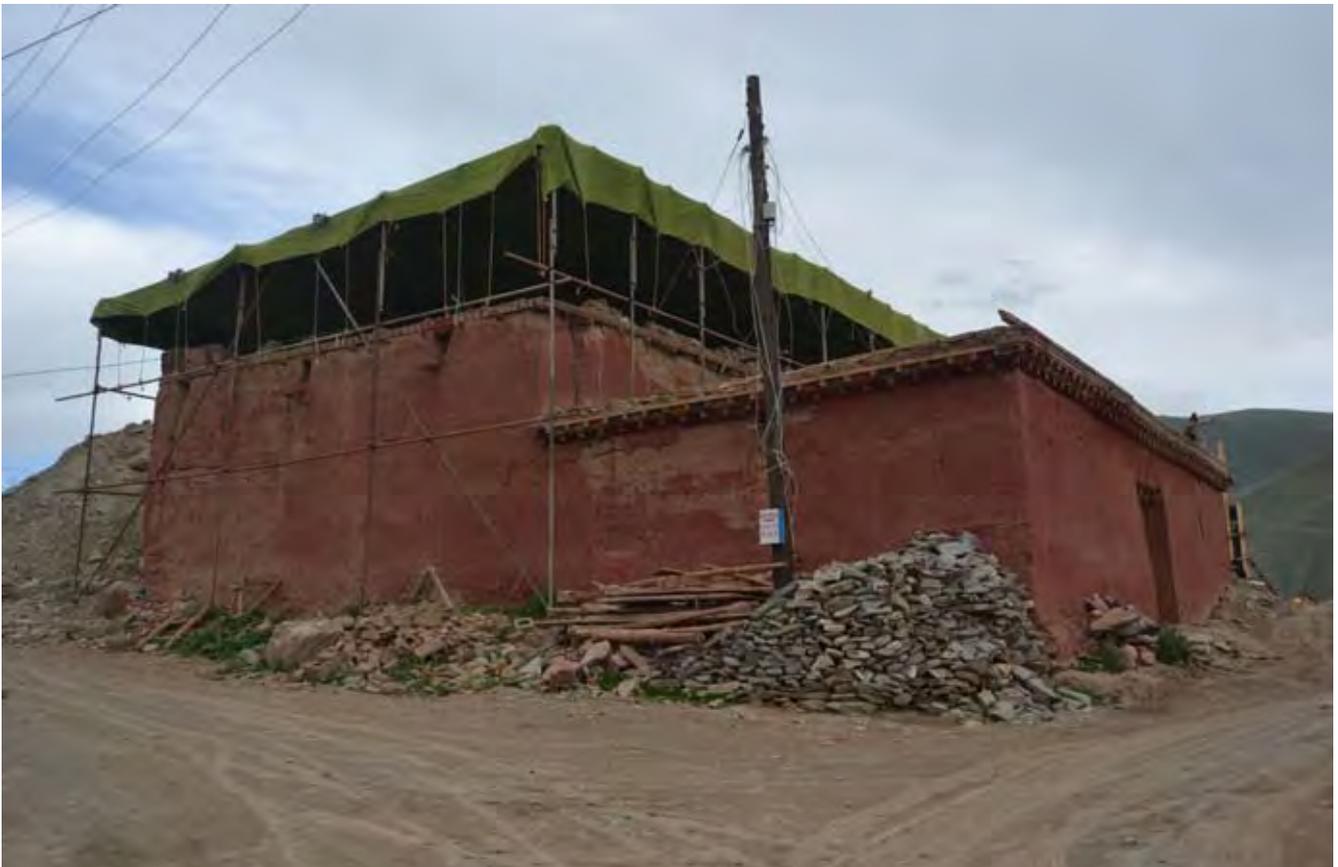
This temporary roof structure was kept for three months.

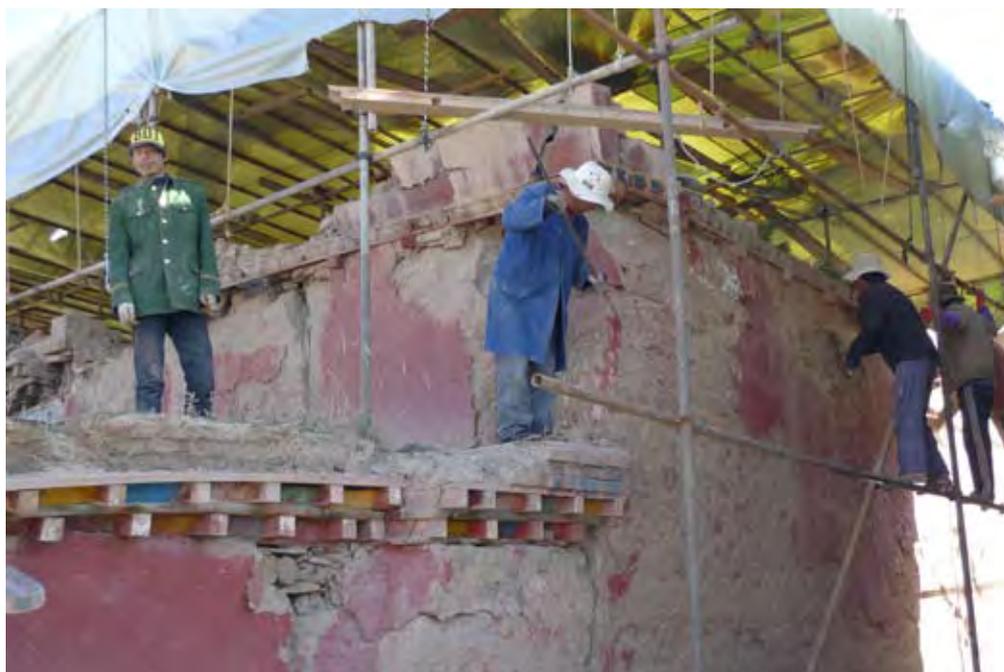
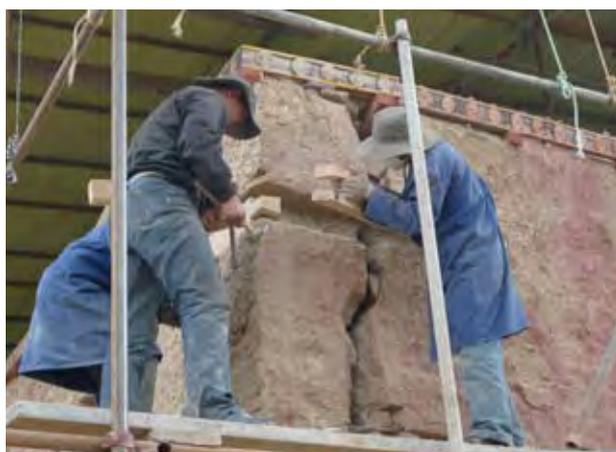
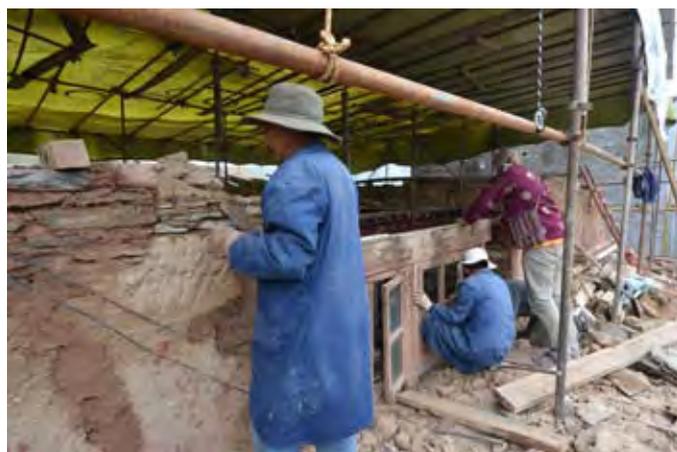
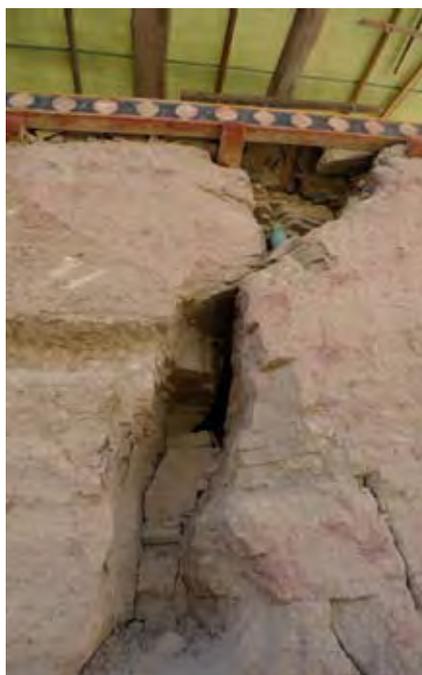
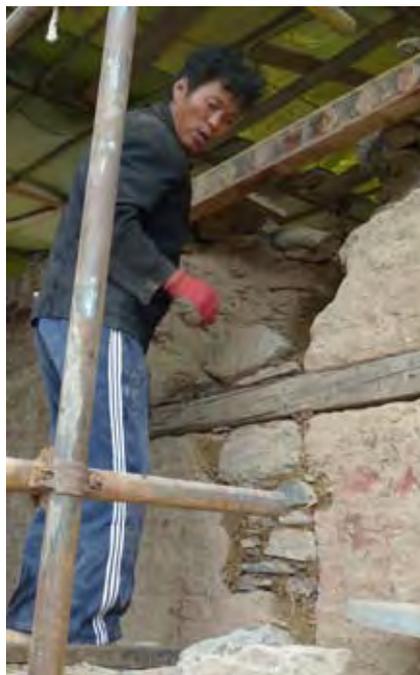
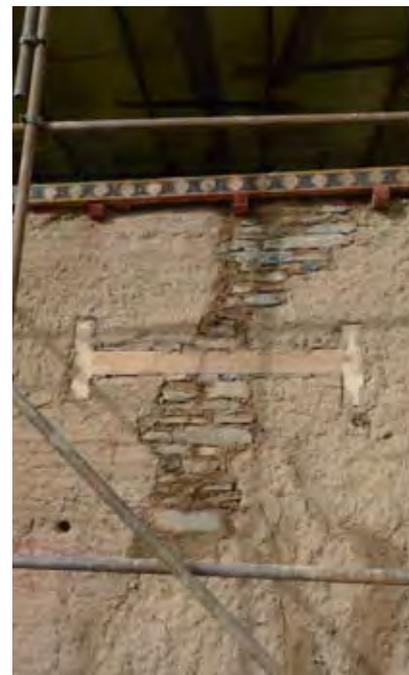
After the wall-paintings had been conserved, it was possible to begin with the structural restoration.

In September, the team removed the exterior plaster to understand the extent of the damage to the walls (see picture on the left). More cracks were found.

All loose soil was removed from the cracked area. The largest cracks were then tied together with wooden beams, smaller cracks were filled with stone masonry (pictures in central row).

Bottom row: before, during and after crack repair.

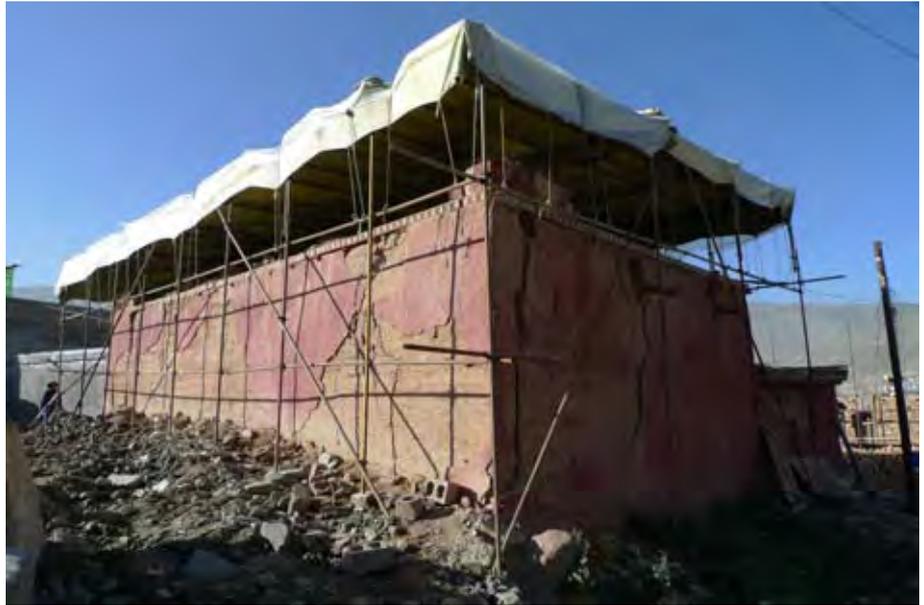
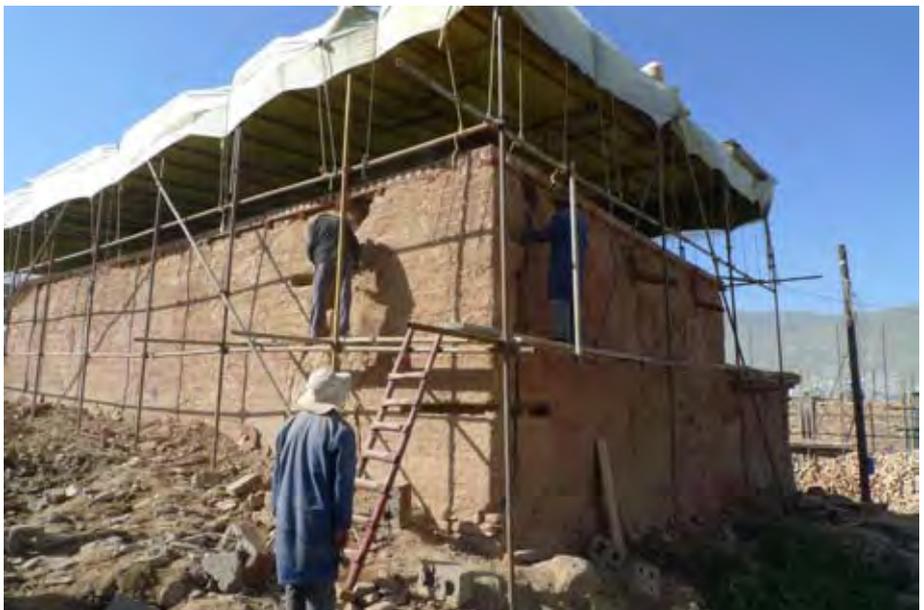
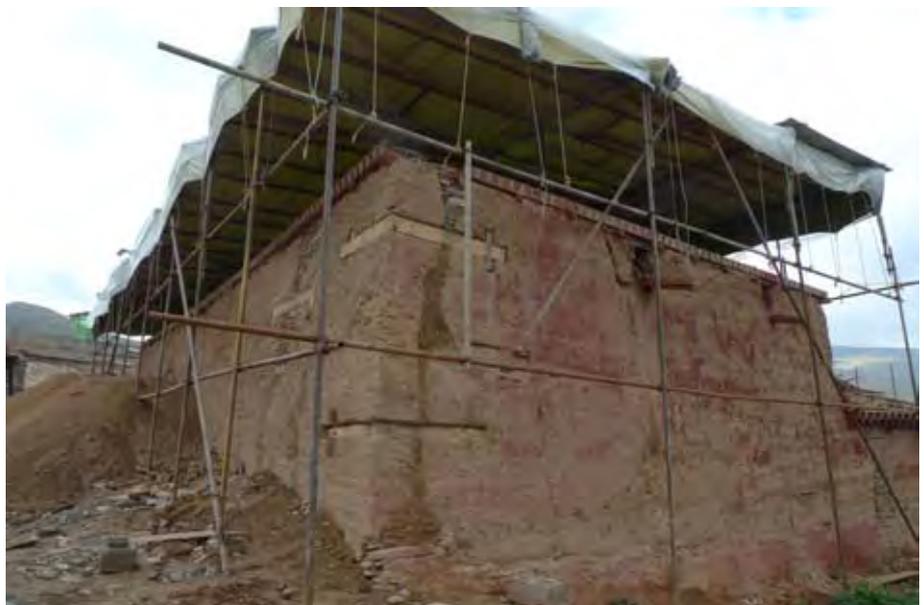
Top: view from north-west corner during removal of exterior plaster.

Middle: masons filling cracks and tying the walls together with beam constructions prepared by the carpenters.

Bottom row: completed structural repairs.

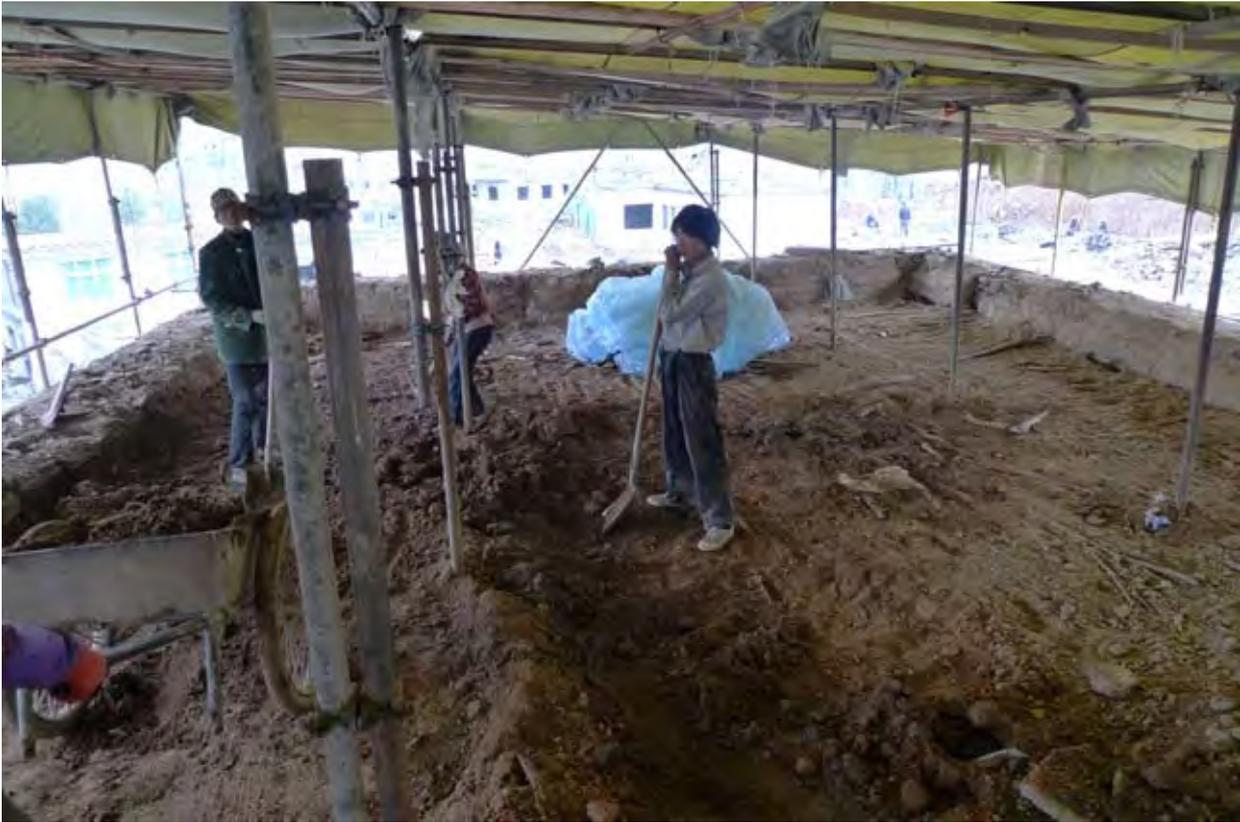
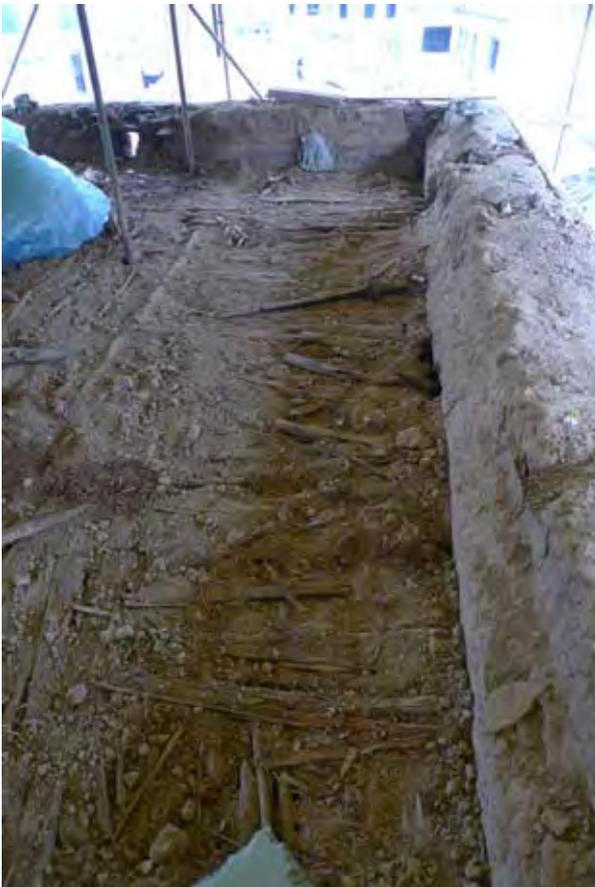
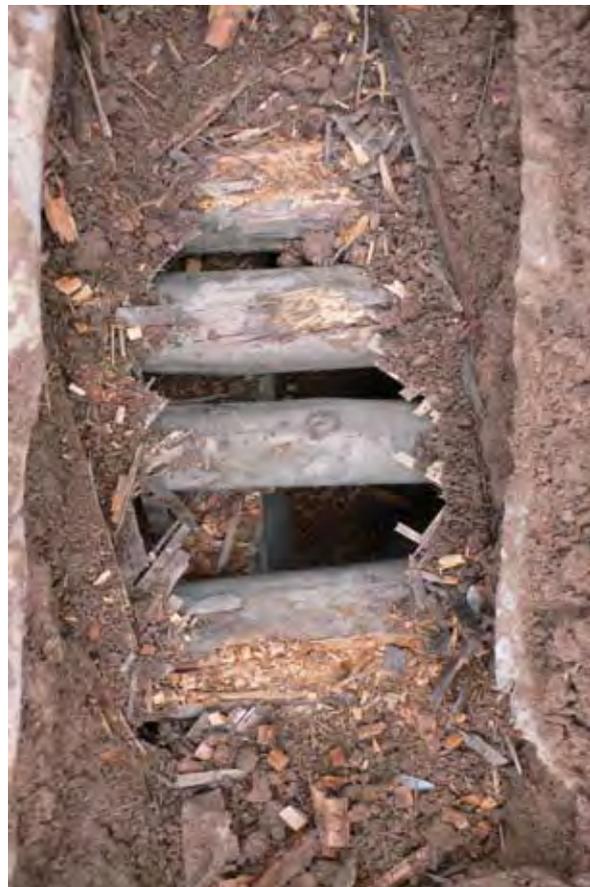
All the top soil had to be removed to expose the timber structure. As expected, over 50% of timber roof elements were rotten and had to be replaced.

The roof was opened - the soil layers were removed and the timber structure dismantled. We found that only 50% of the roof timber elements could be re-used. After removal of the weight, the bent columns and beams could be successfully straightened, to re-create the original structural balance. The new roof timber system was improved by using better quality timbers (the old one consisted of many bent or very short timbers). On top of the traditional roof soil a new layer of flat slate stone was placed for water-proofing, and more water spouts for drainage were added. The parapet was rebuilt with mud and slate stones.

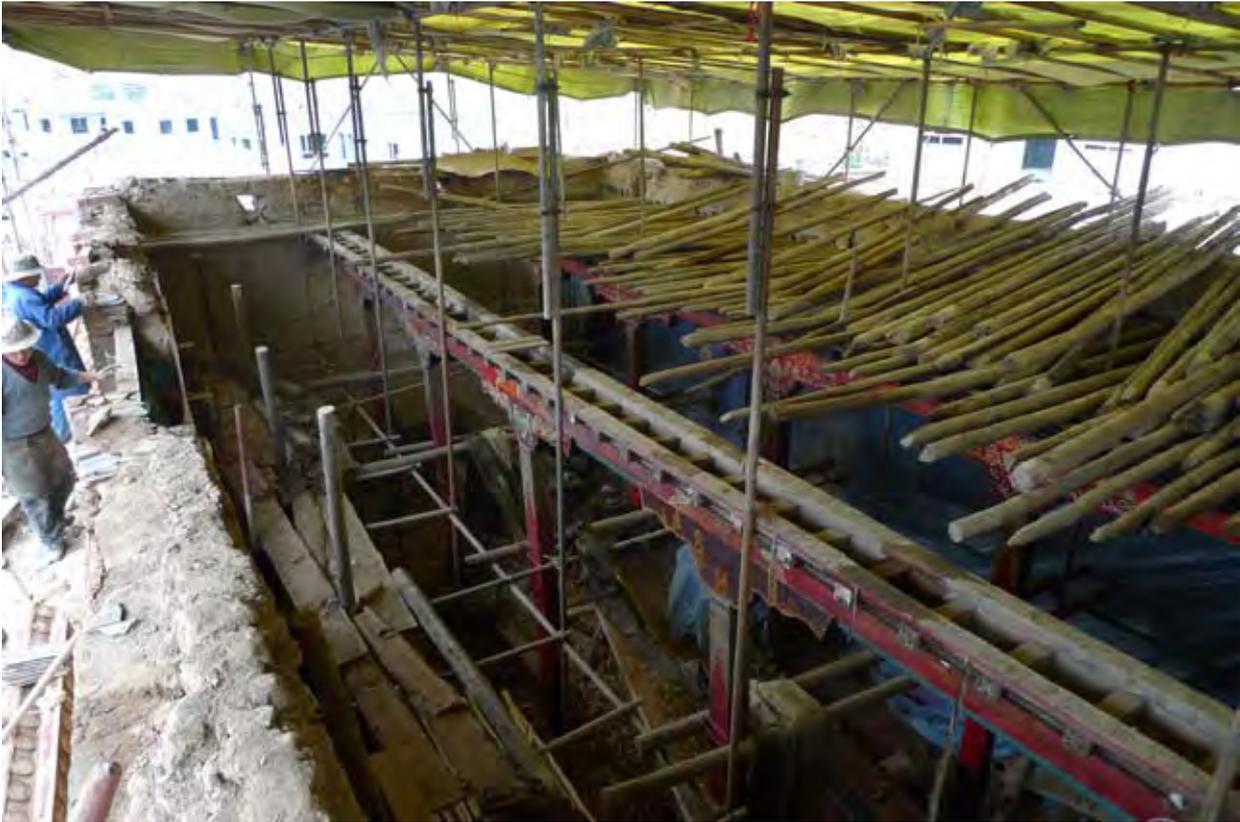
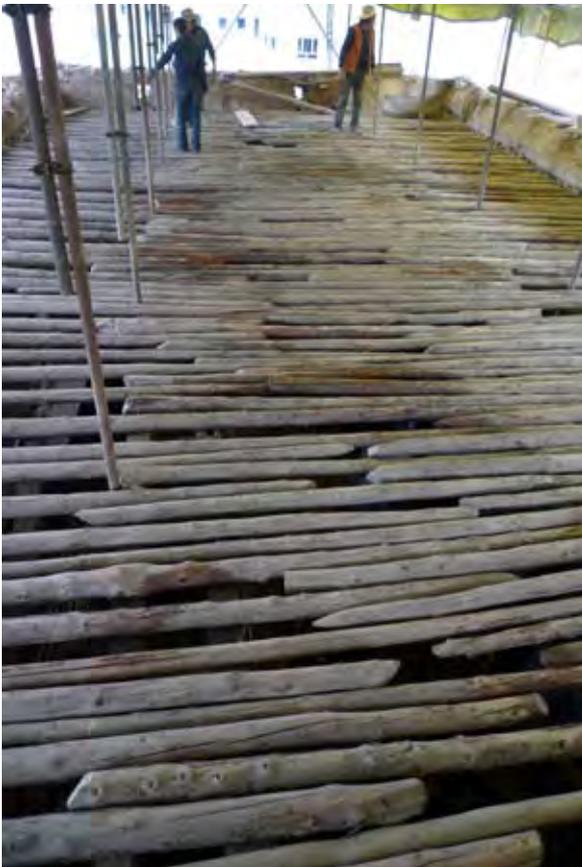
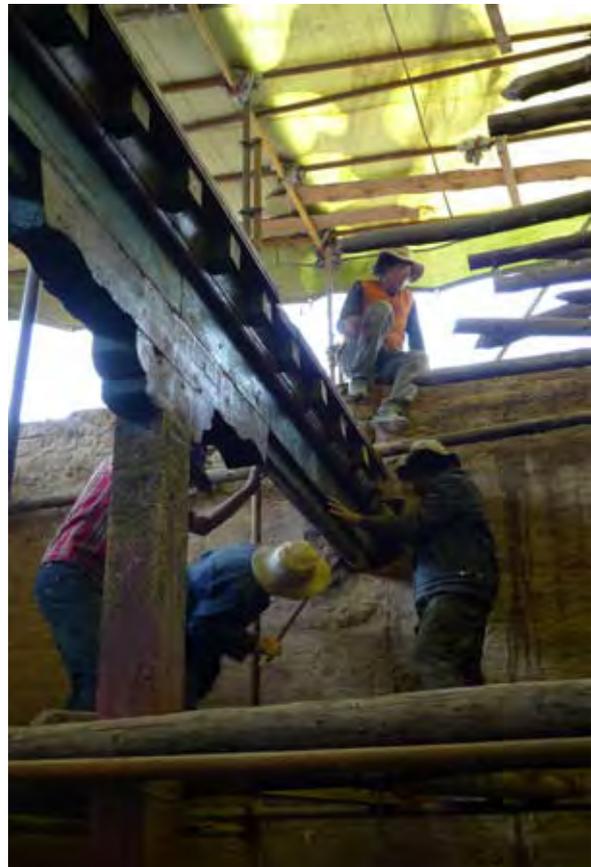
The carpenters dismantled the wooden roof structure. The original structure was laid very haphazardly, presumably due to lack of money, beams of different sizes and qualities were used. After selection of the re-usable ones, we decided to lay the roof structure using beams of uniform size and strength. This looks better, and is also stronger. Once the roof load was gone, we could straighten the deformed column- and beam-structure (below right).
