THF WORK REPORT JYEKUNDO OLD TOWN RECONSTRUCTION 2011

## RESTORATION OF KARTSOG LHAKHANG

## ARCHITECTURAL SURVEY

# STRUCTURAL INTERVENTION

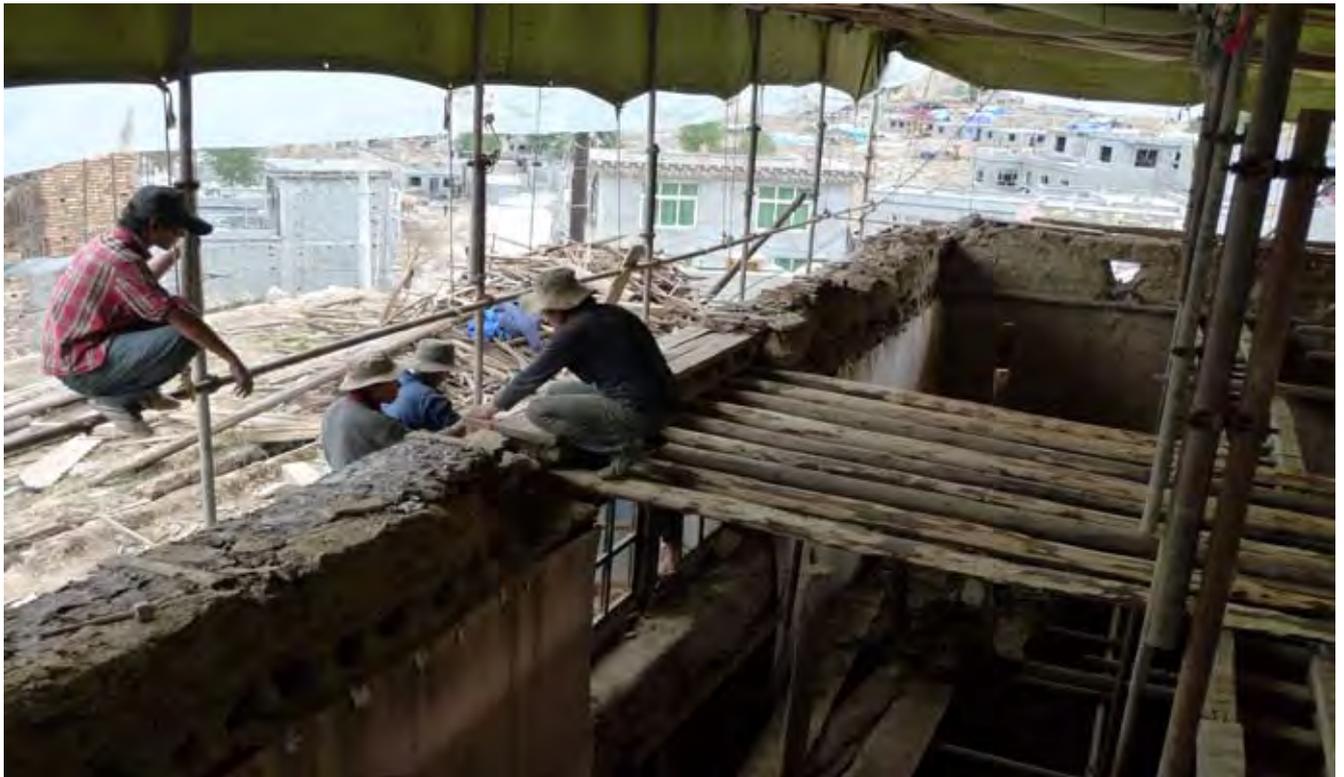
The carpenters have prepared the new roof timbers, and cleaned the re-usable original ones. The masons have prepared new holes in the walls. The new beam structure can be laid.

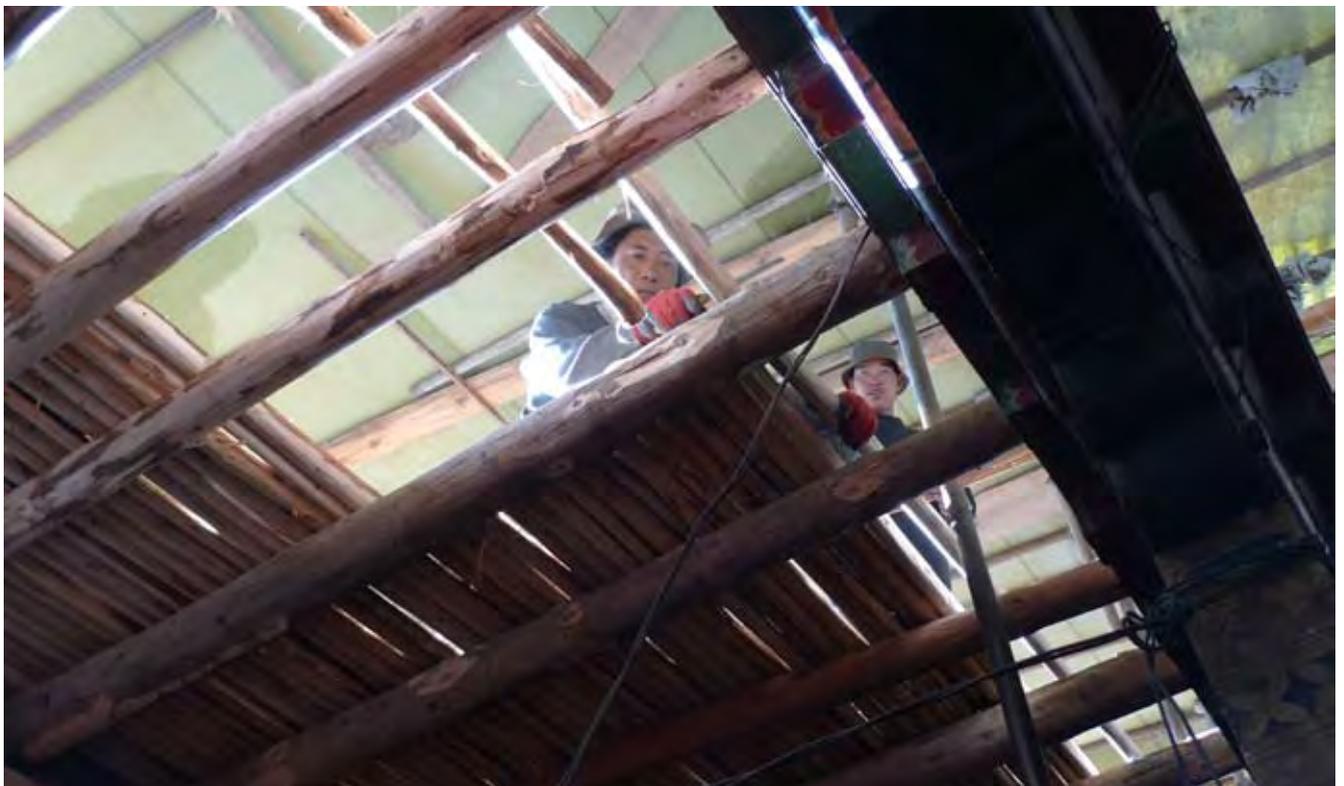
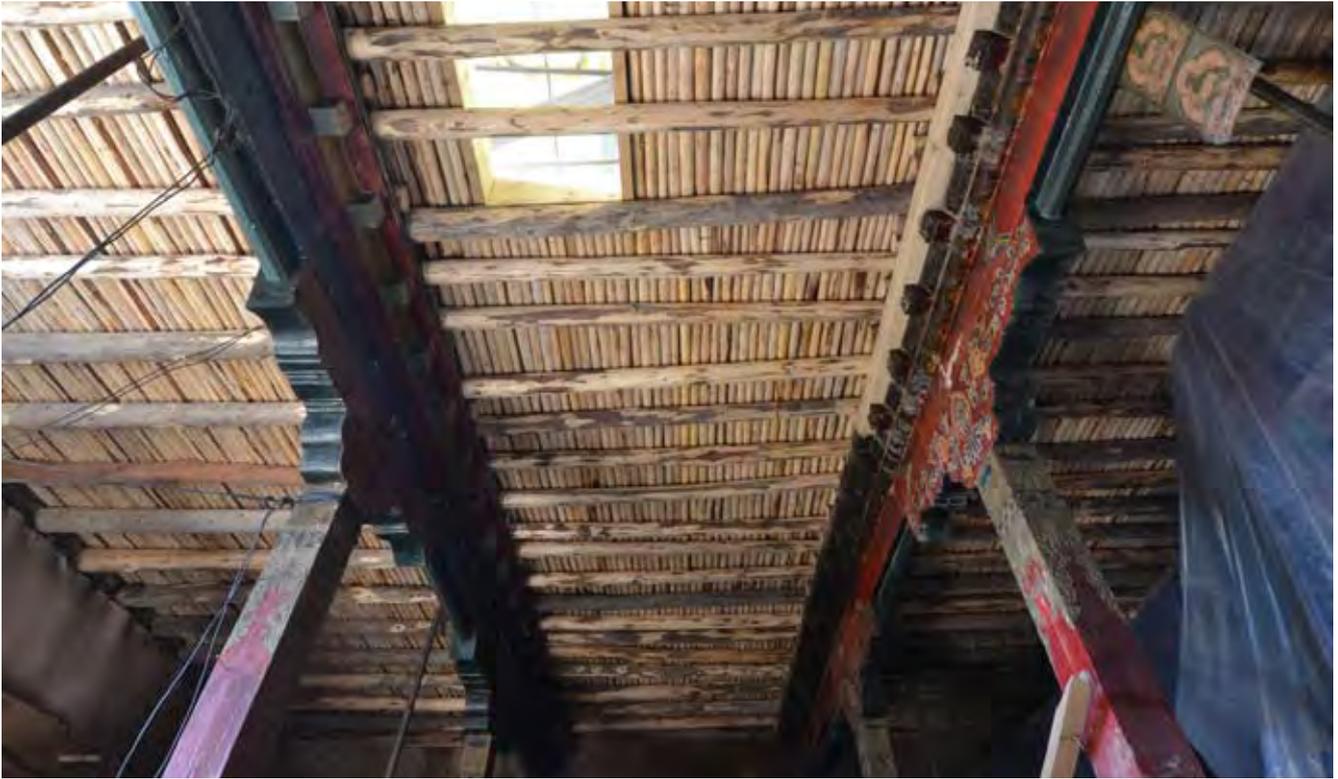
The new roof structure is more regular than the old one. Now the load is better distributed, and the structure is much denser and stronger.

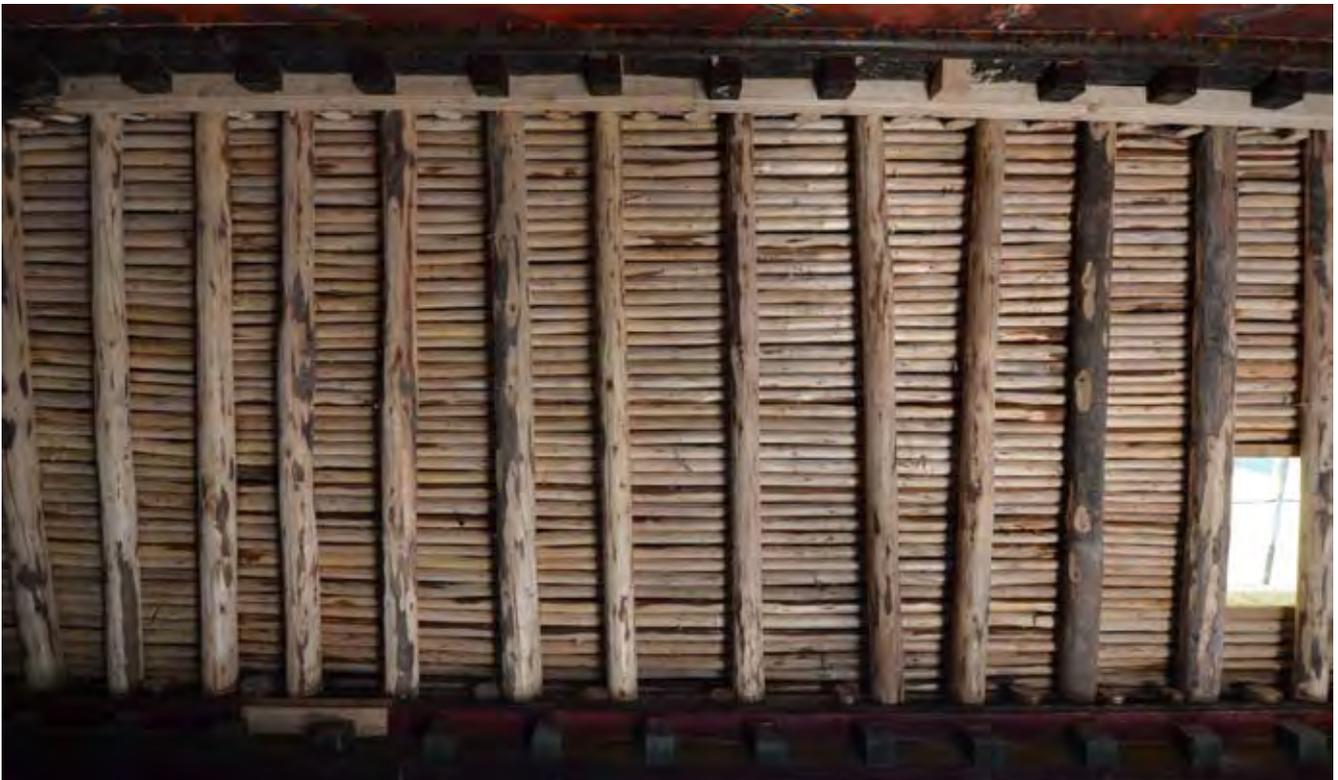
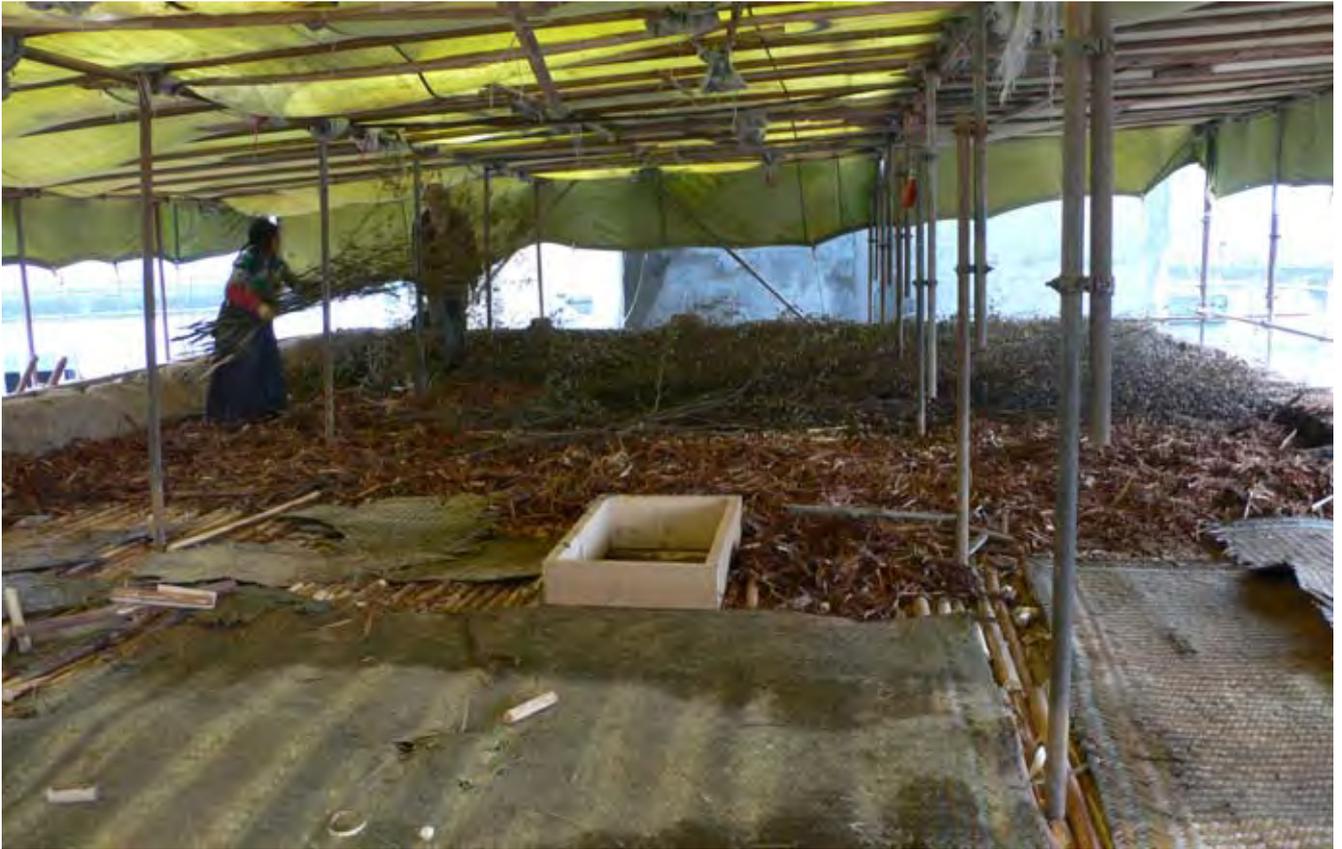
The layer of rafters and joists is covered with straw and cloth mats, on which first twigs are placed, then mud.

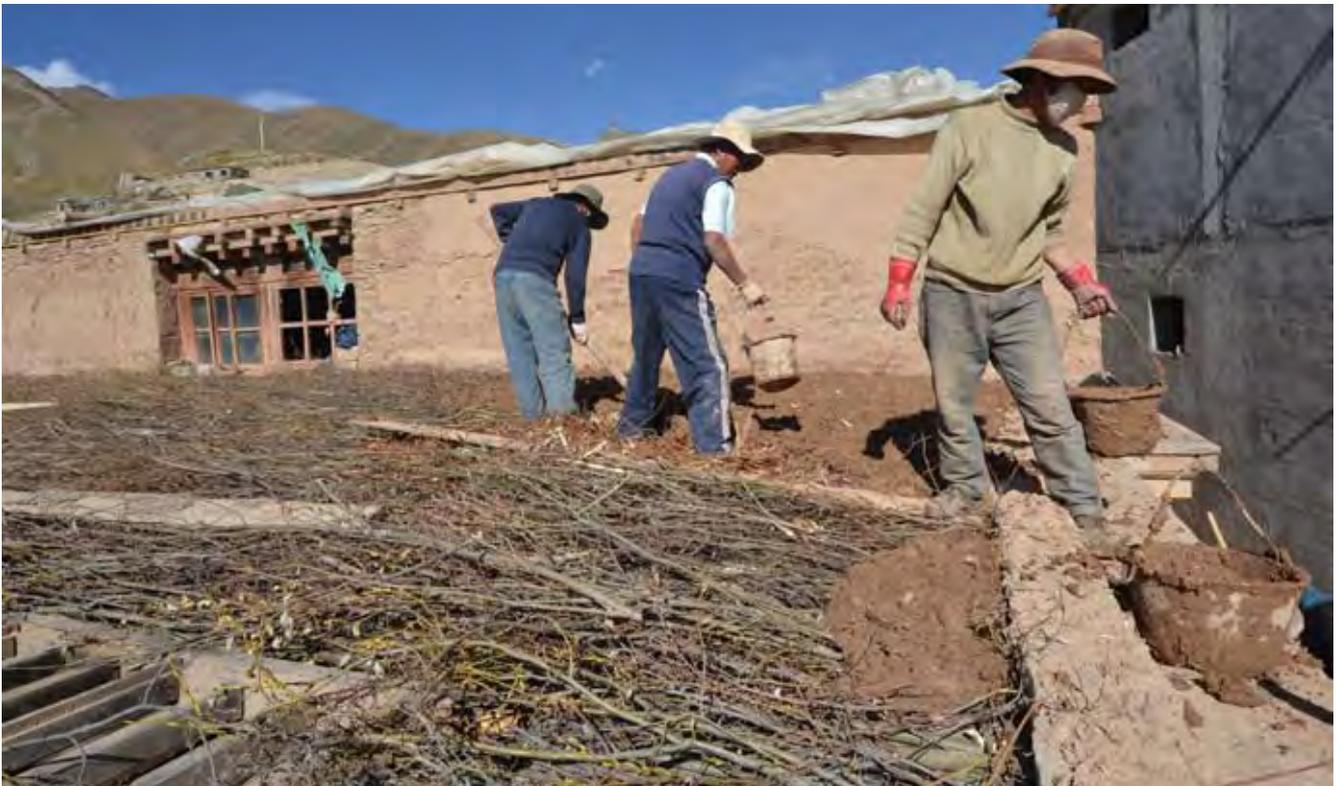
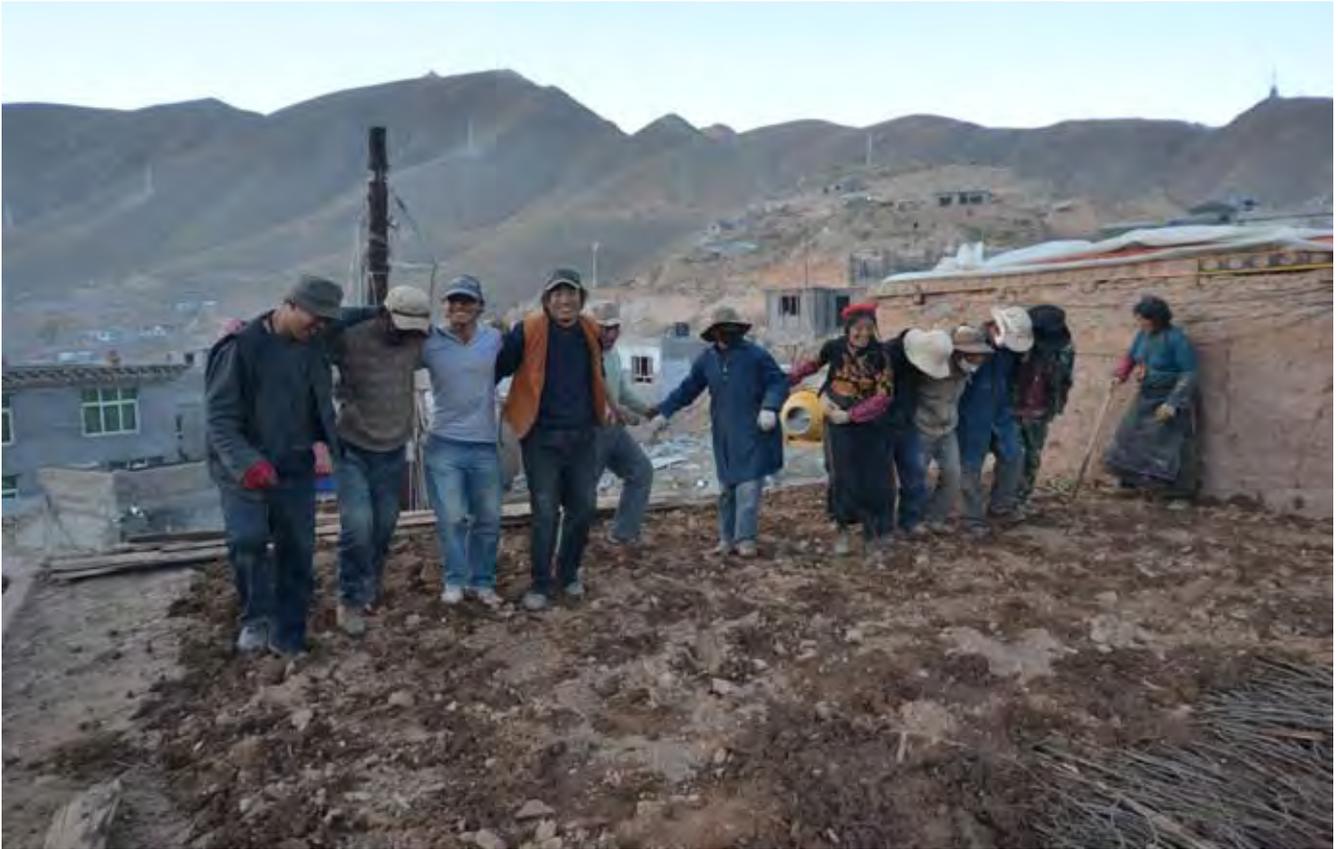
According to local tradition, the mud is condensed by dancing on top of the (nearly-) completed roof.

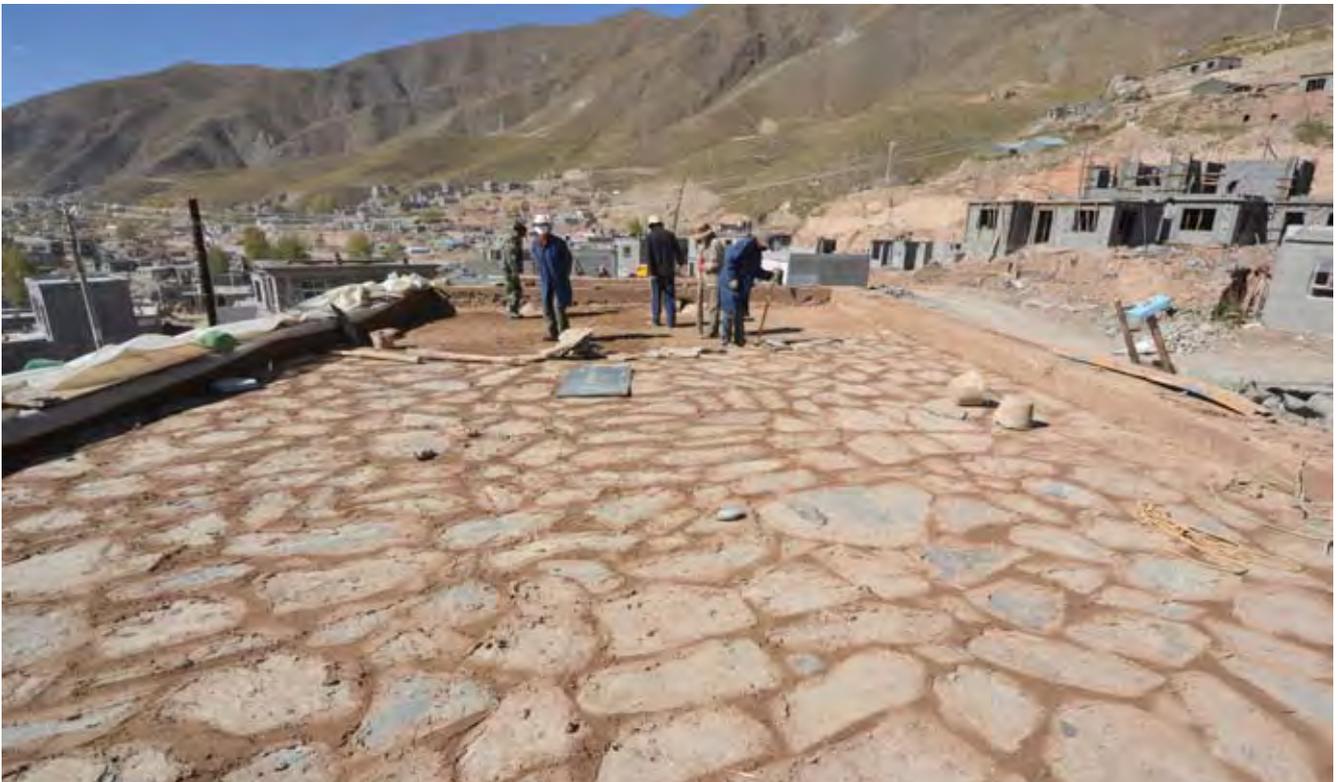
To make the roof really water-proof, we added another layer of flate slate stones on top, on which rain water can run down towards the spouts (we have used this successfully elsewhere).

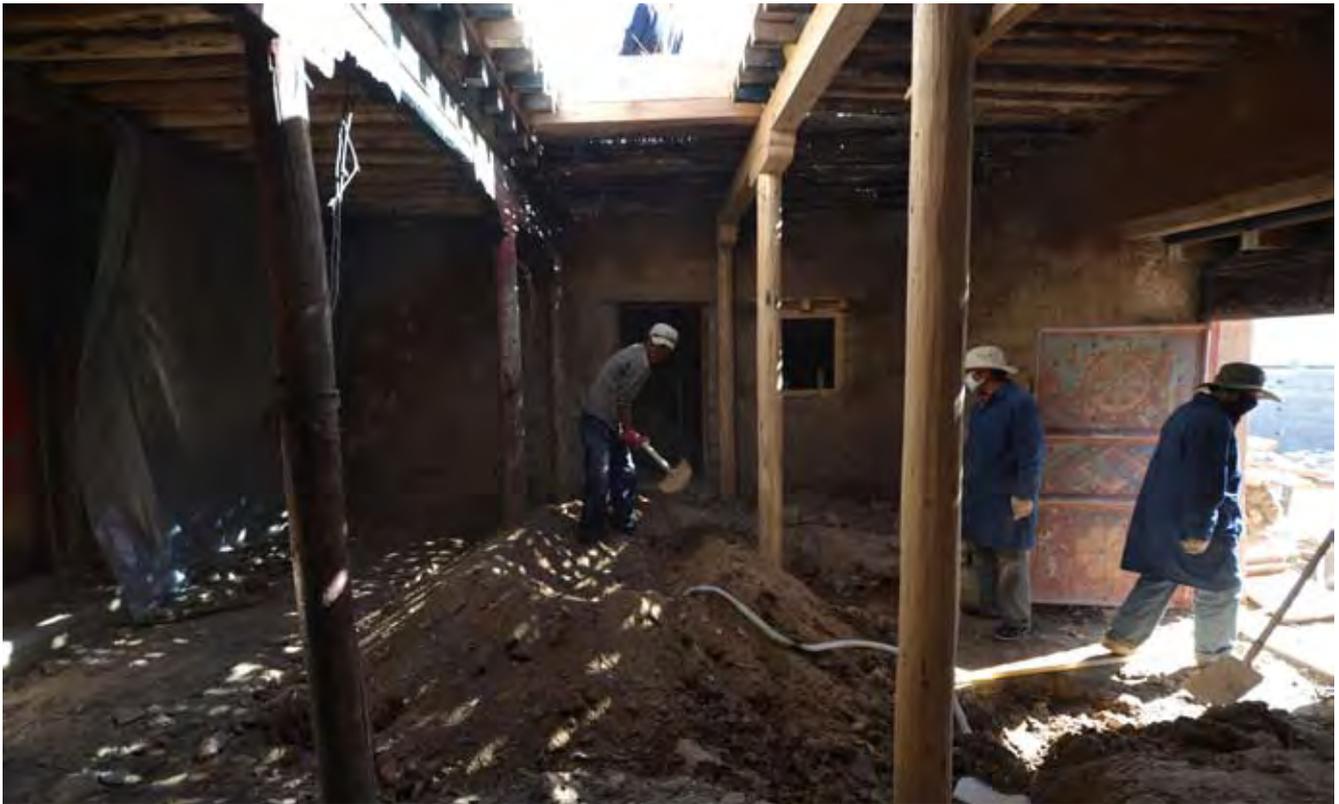
Work on the entrance portion included removal of later partition walls, and building a new skylight.

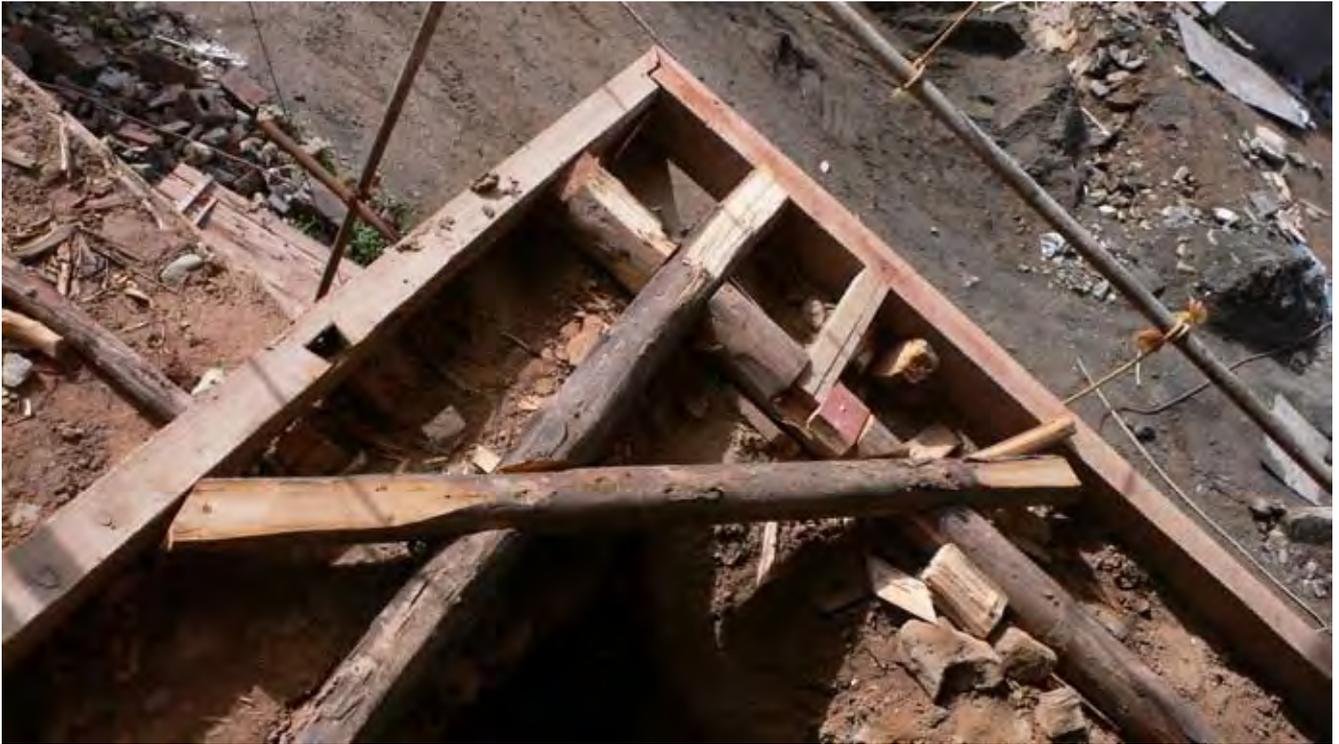
The wooden roof parapet structure was reinforced to create a set of tie beams that hold the entire building together.

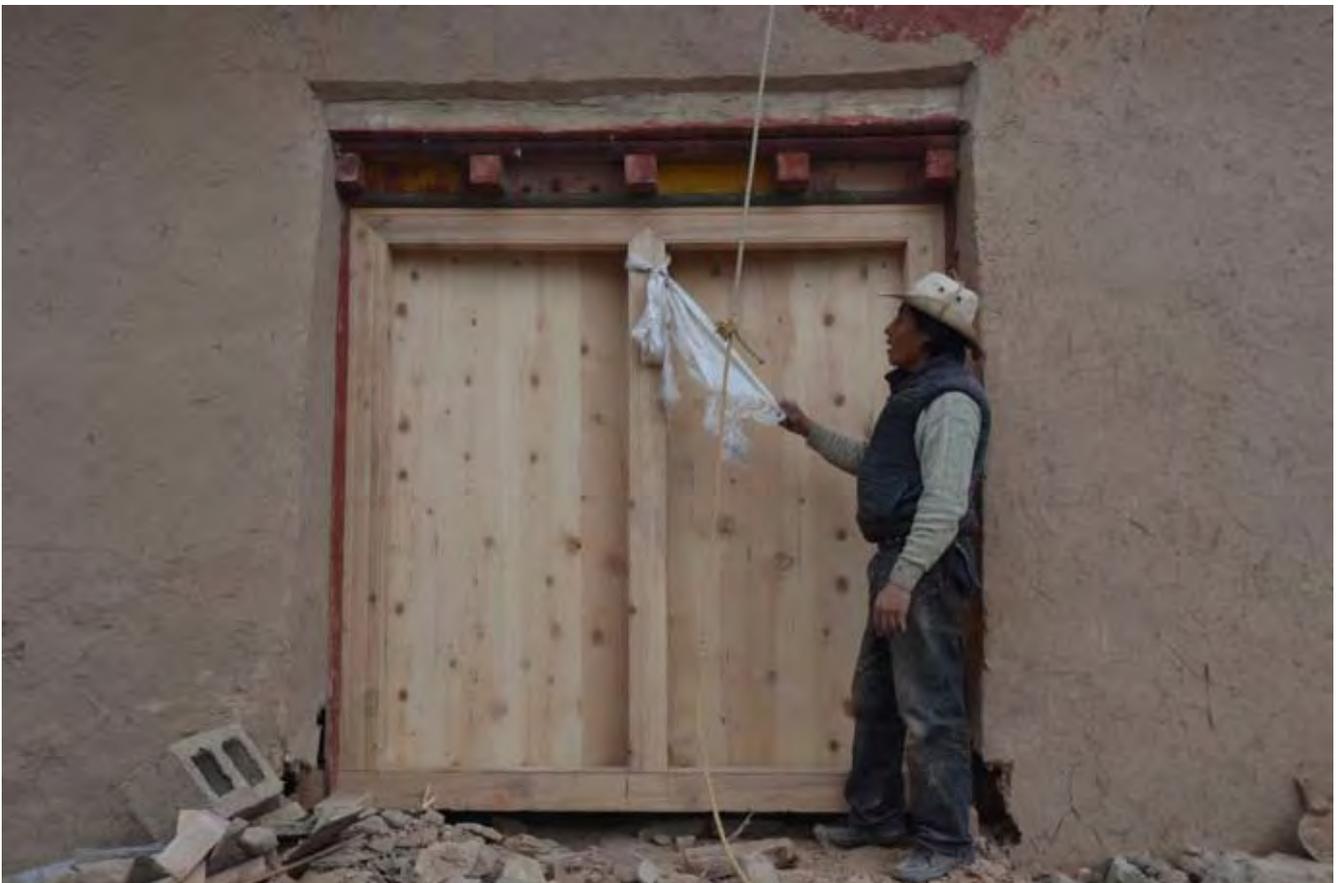
The modern iron door was replaced with a traditional wooden gate.

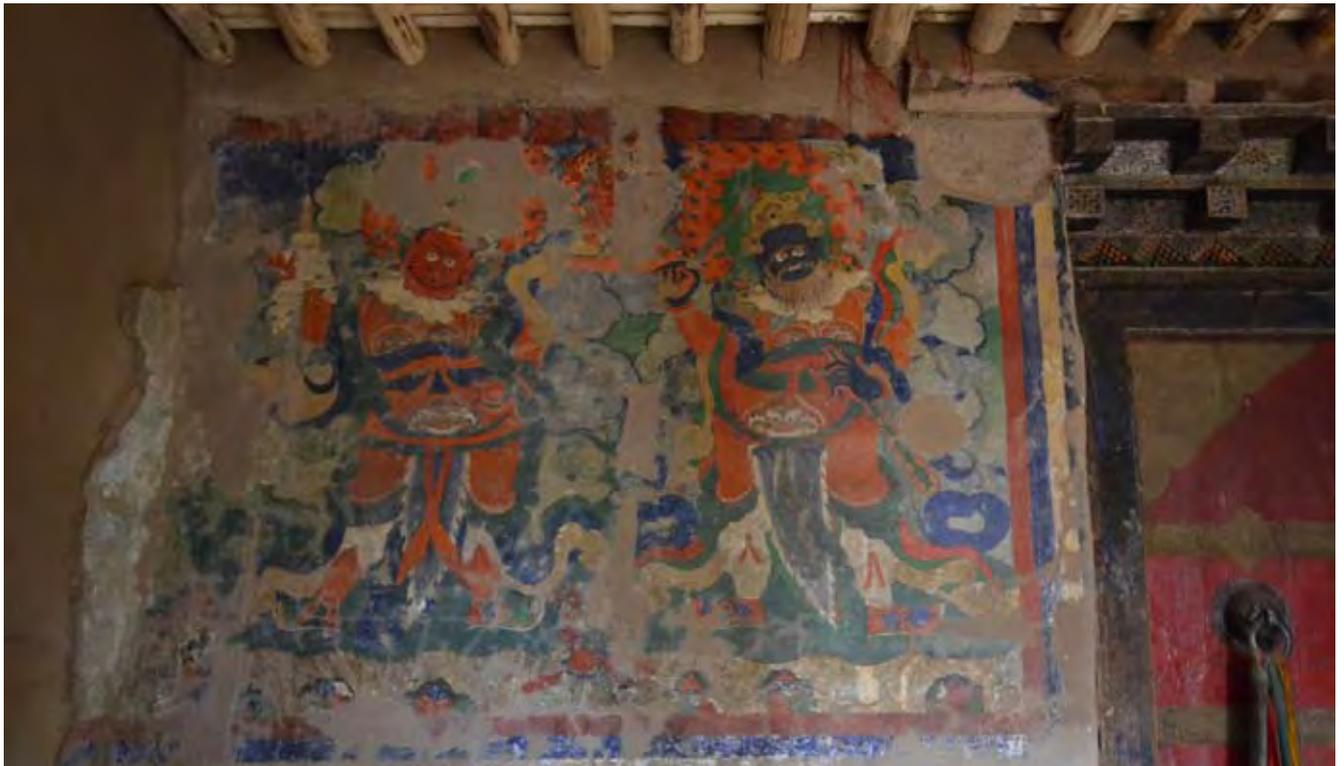
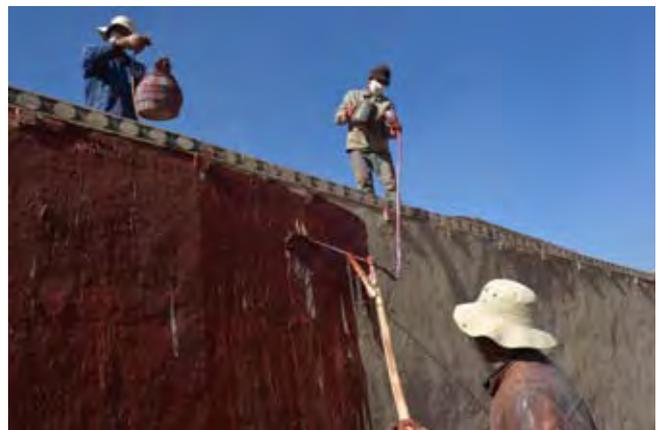
**1 Conserved and cleaned wall-paintings**

All historic paintings in the temple have been stabilized, conserved and cleaned, seen here the entry area paintings of two of the four gods of the four directions.

**2 New sky-light**

A new sky-light was built for the courtyard in front of the main hall. This courtyard is used to accommodate visitors during times of important teachings and religious practice, when the main hall is often too small to accommodate everyone.

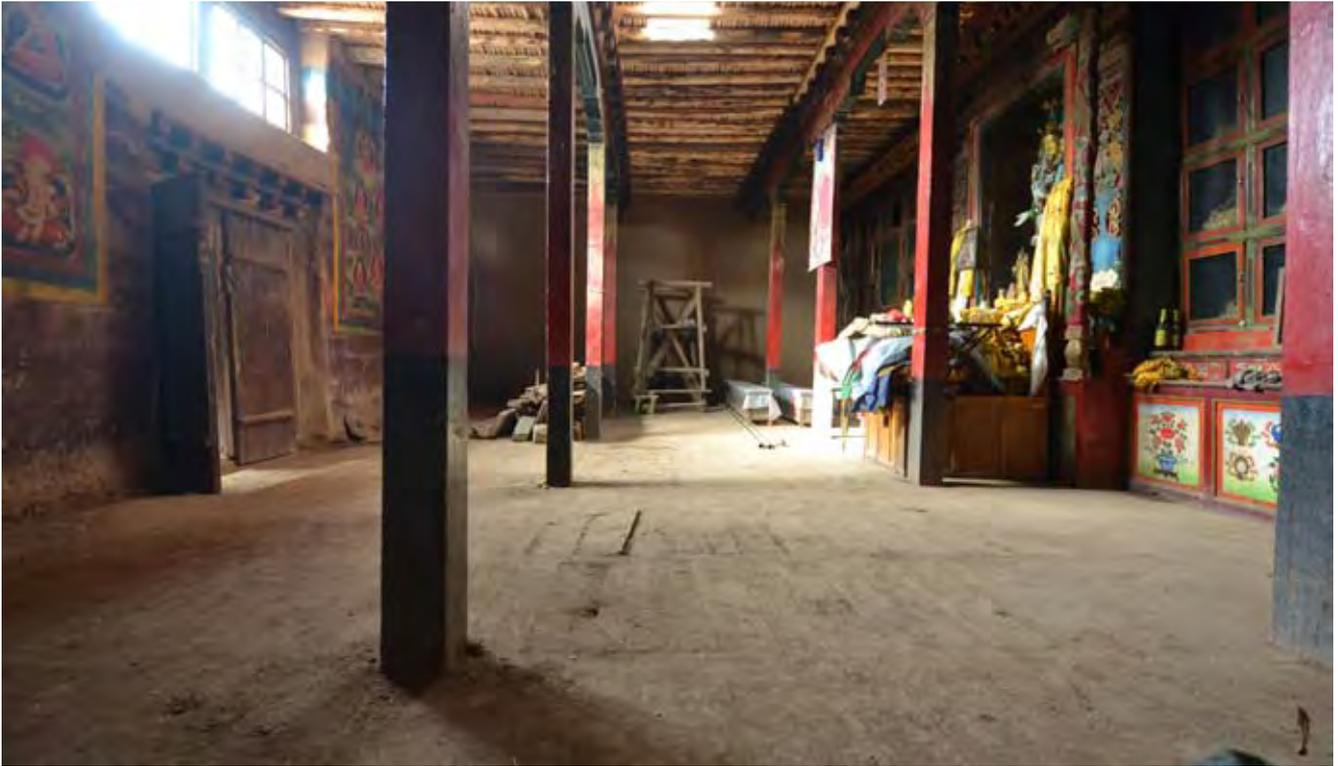
4

**4 View of completed interior**  
The completed main prayer hall, October 2011.

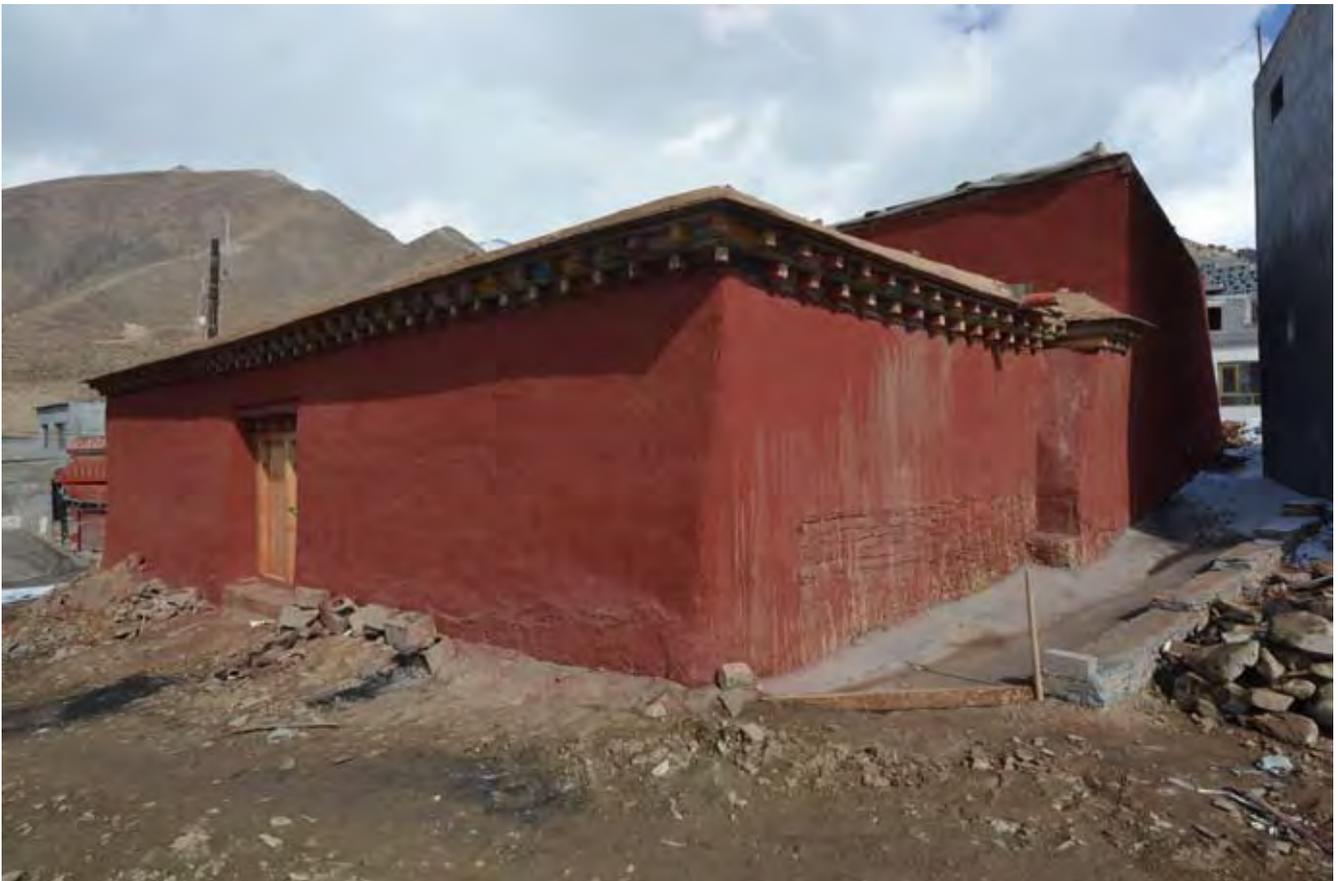
5

**5 View of completed exterior**  
The restored Kartsog Lhakhang, October 2011.

The last step was to paint the walls red, as they were before. We used the same natural earth pigments, locally available..

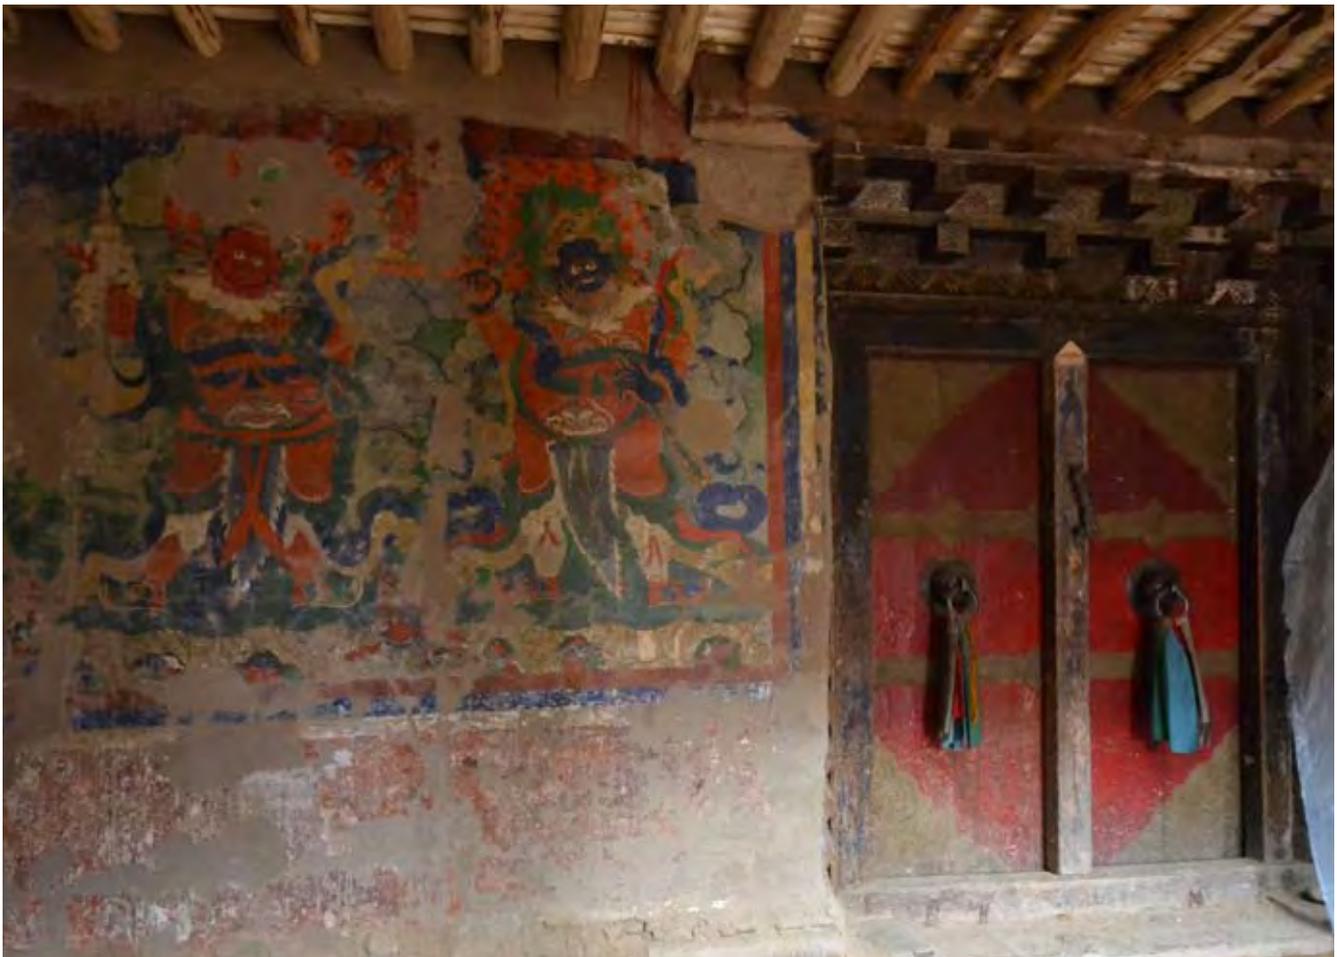
Restored entry, November 2011
