YUNGDRUNGLING MONASTERY Conservation Project Report

by André Alexander and Christine Jürgens,
with Nyima Tsering and Uli Ulbrich

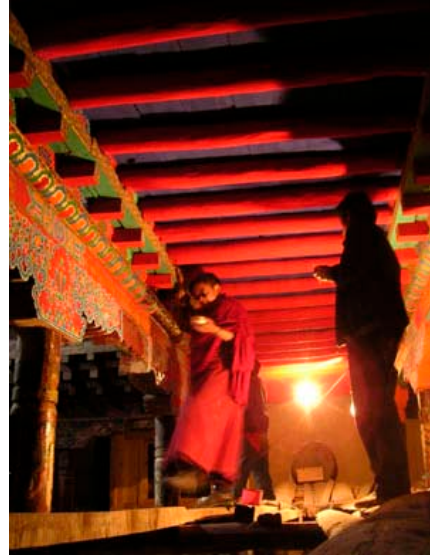
fig. 45 (left): detail, depiction of figure (lha rgyal bkra -) that was optically completed by local-retouching on dress and background

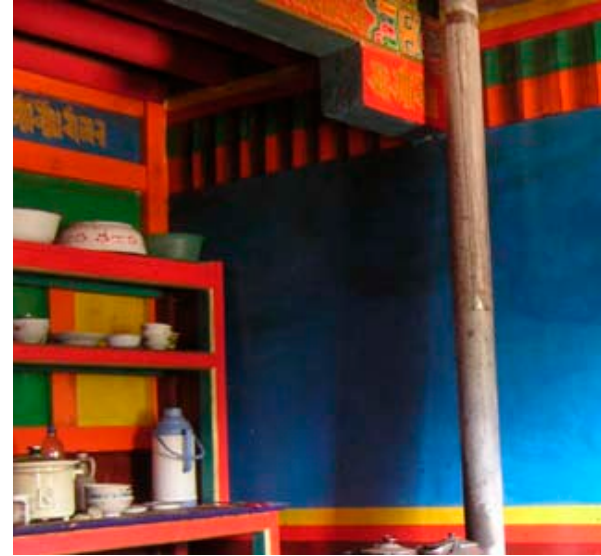
fig. 46 (center): monk Tsewang was an active participant during all stages of the work, seen here retouching the restored timber frame elements

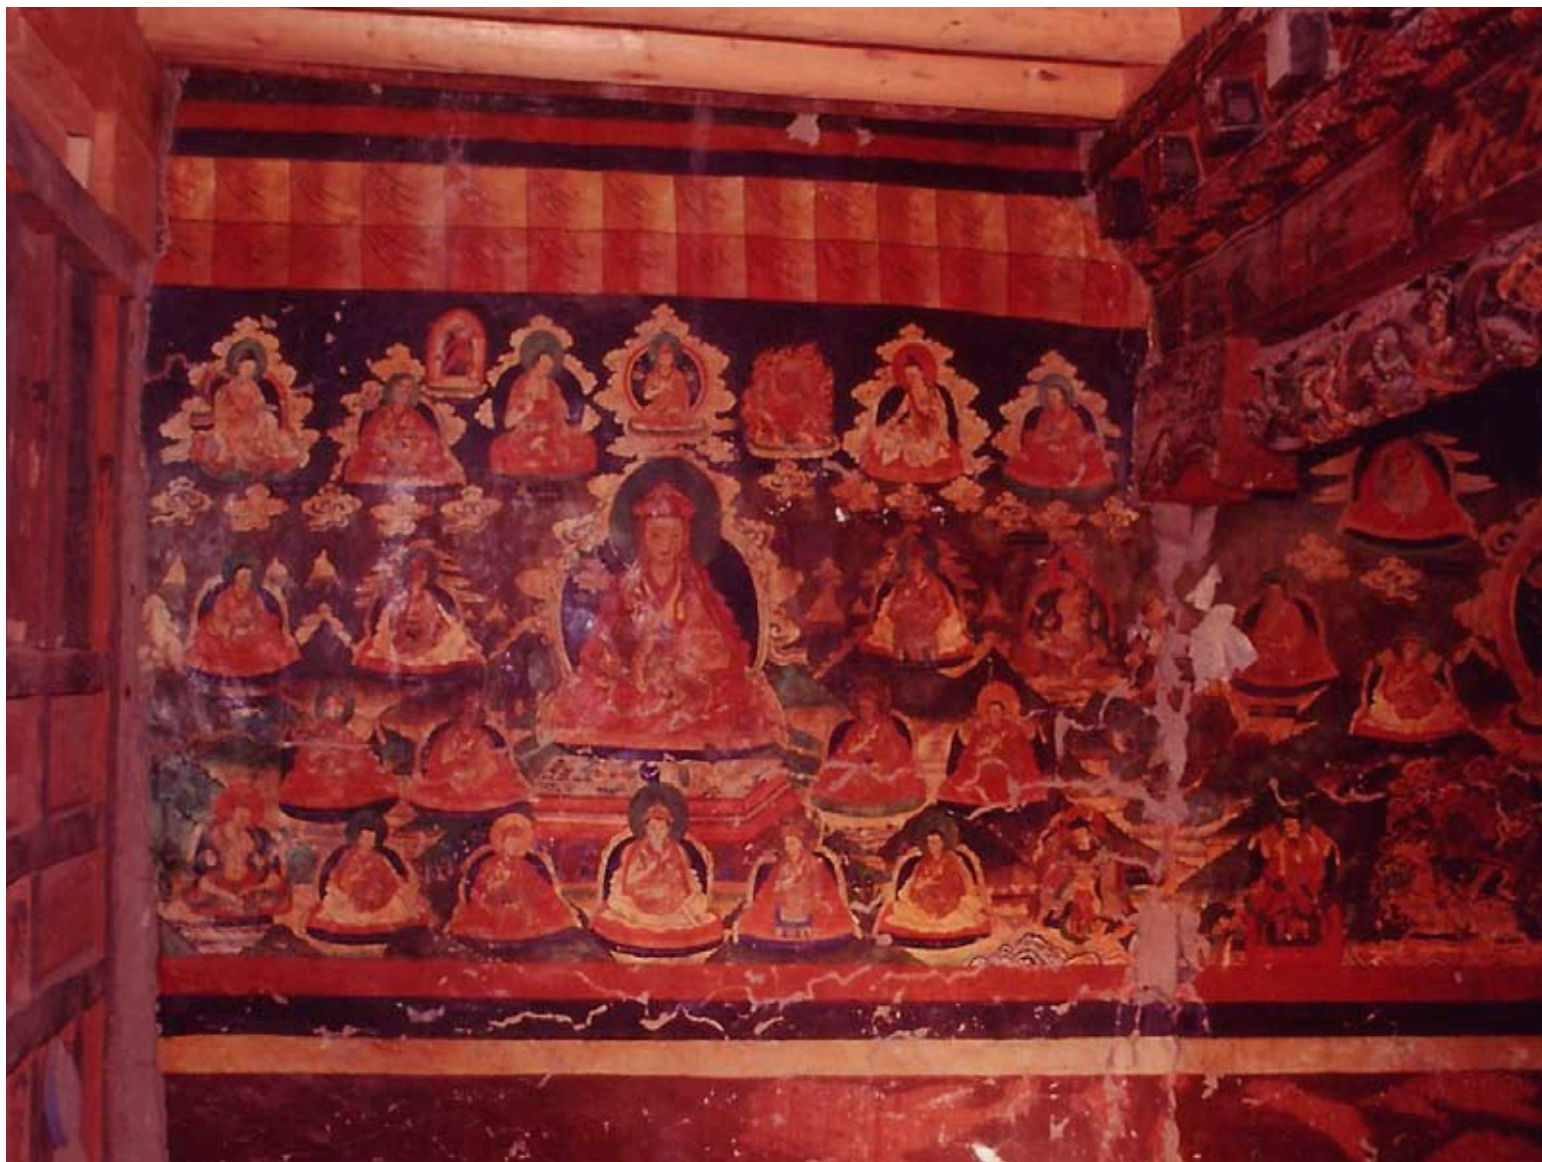
fig. 50: painting section 2-1 before conservation work

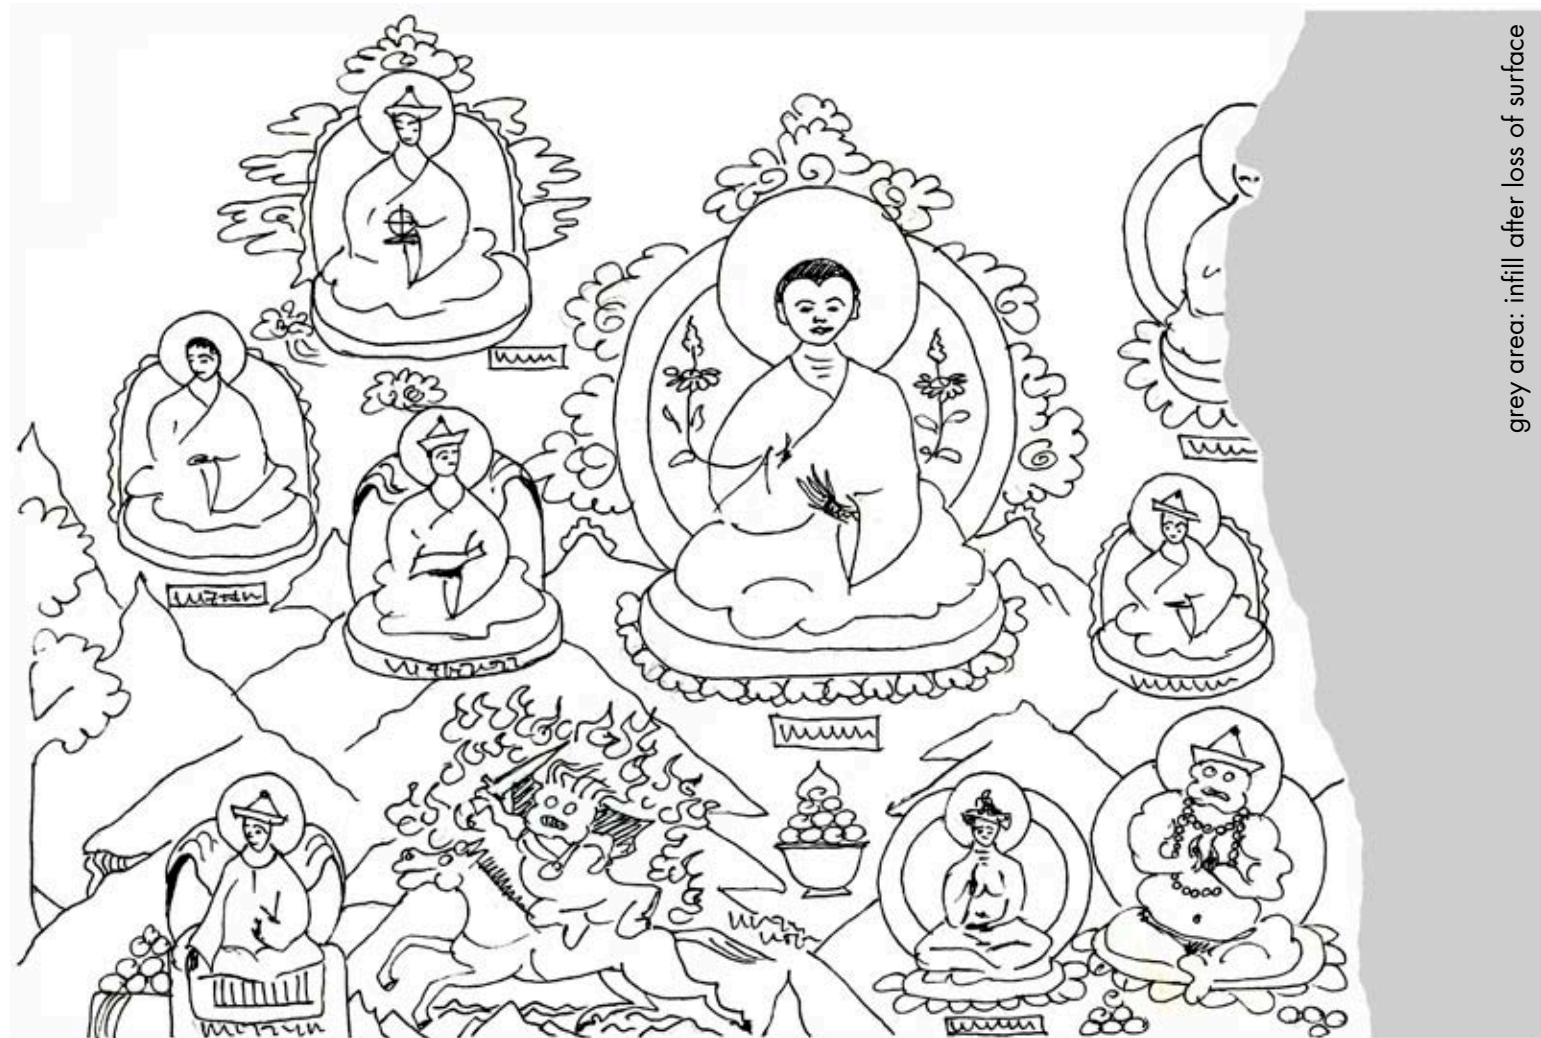
fig. 58: painting section 2-2, sketch
by C. Schmaltz

grey area: infill after loss of surface

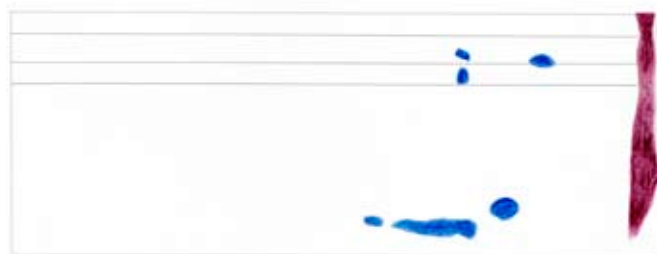
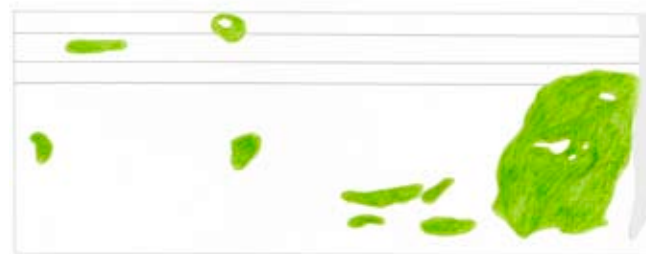
fig. 66..69: boundary parts of painting section 2-2 with analysis of damages

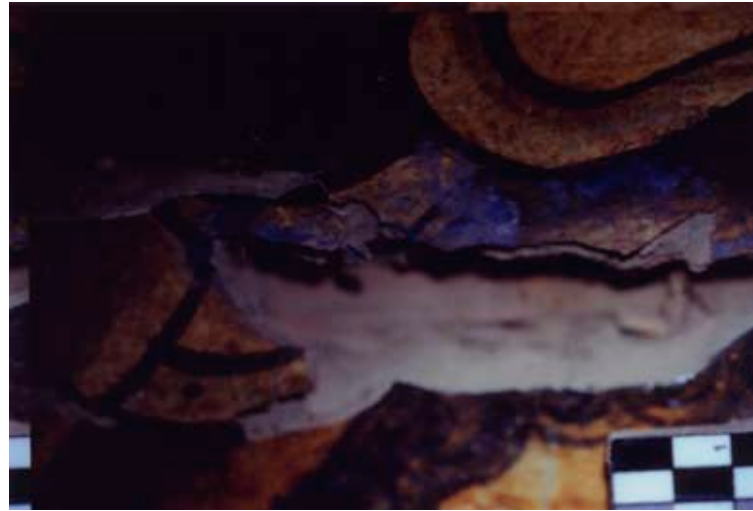
fig. 108 (left): old retouching on an old filling, which was subsequently removed

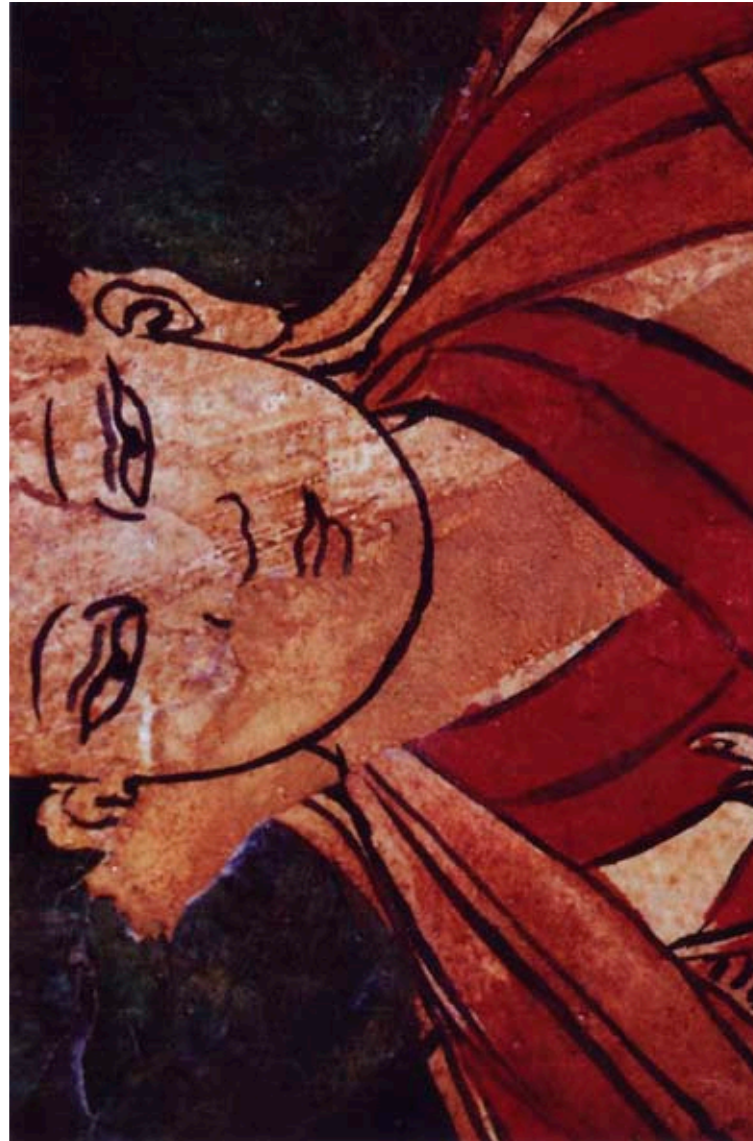
fig. 118 (left): „local retouching“, fill colours and some basic lines strongly repainted due to the long horizontal cracks - this is necessary so that the image becomes iconographically complete.

long horizontal cracks, where it was not possible to close the painting only by a local-retouching, were retouched with more details. But a pure full-retouching was avoided, details like eyes, noses or hands have never been repainted.

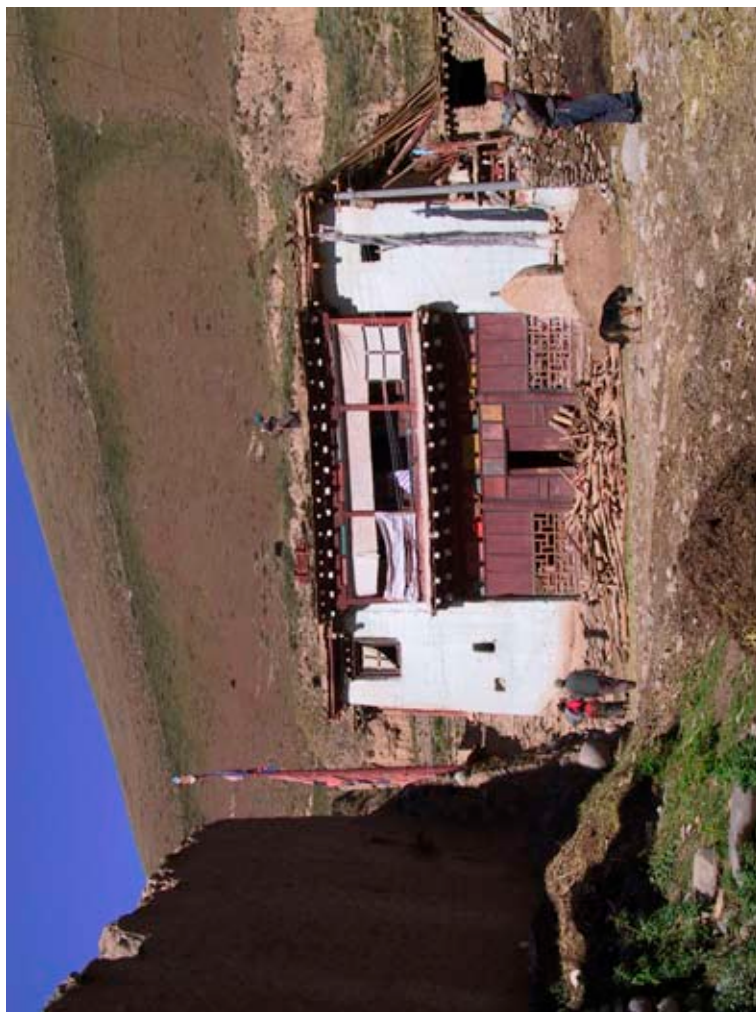
*fig. 120: Yundrungling monastery
before intervention*

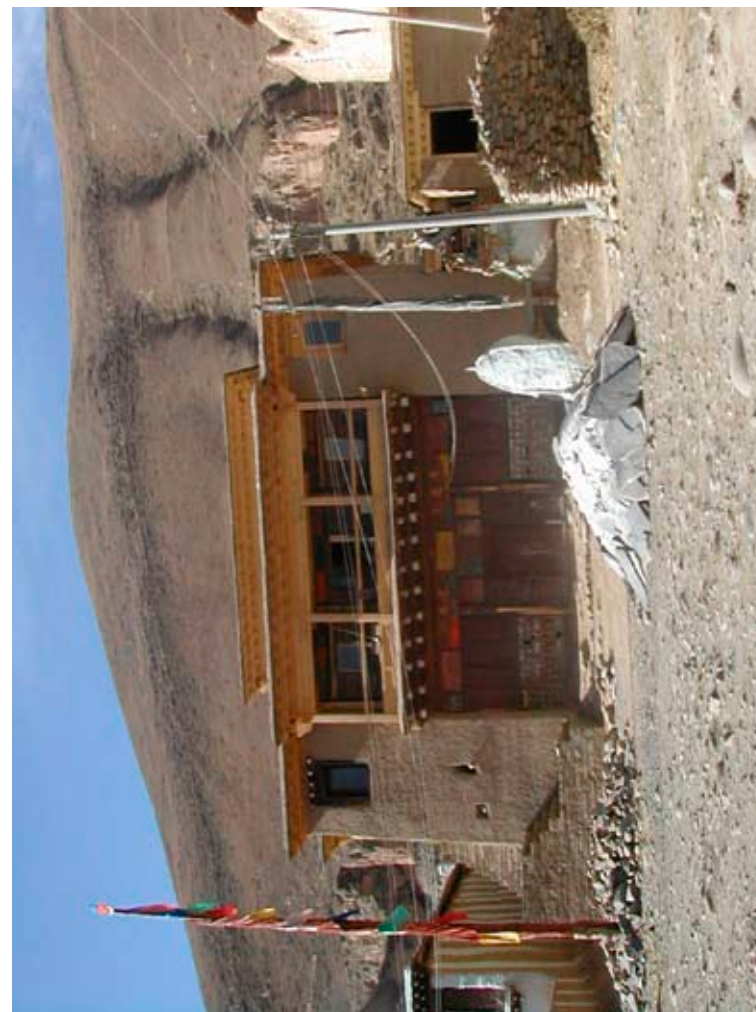
*fig. 121: the monastery at the end of
2003*
